# Reducing sediment sources to the Reef: Managing alluvial gully erosion

Andrew Brooks, Graeme Curwen, John Spencer, Jeff Shellberg, Alexandra Garzon-Garcia, Jo Burton and Fabio Iwashita in collaboration with Trish Butler

Brooks, A., Spencer, J., Curwen, G, Shellberg, J., Garzon-Garcia, A, Burton, J. & Iwashita, F. (2016) *Reducing sediment sources to the Reef: Managing alluvial gully erosion*. Report to the National Environmental Science Programme. Reef and Rainforest Research Centre Limited, Cairns (375pp.).

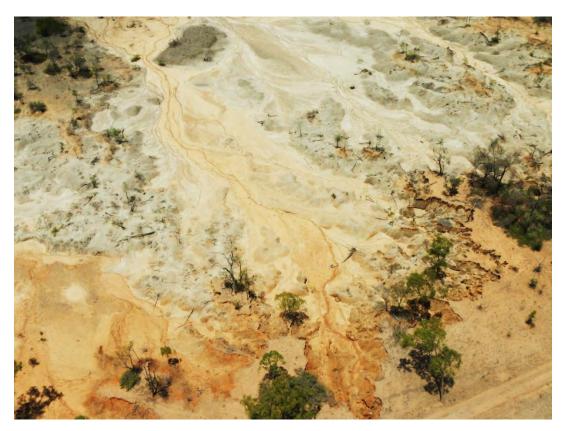
Oblique aerial of an alluvial gully in the Bowen Catchment.

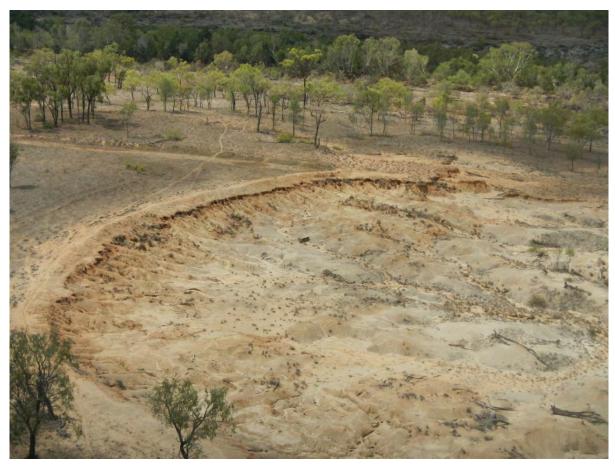
An example of attempted gully stabilisation in the Bowen catchment by gully regrading and the construction of a BERM – but with no soil treatment. Such an approach has in all likelihood increased sediment production from this gully.

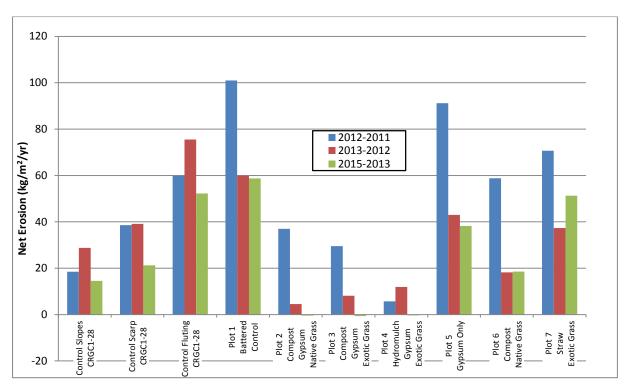
Figure 2: Net erosion across the three monitoring periods (4 years)

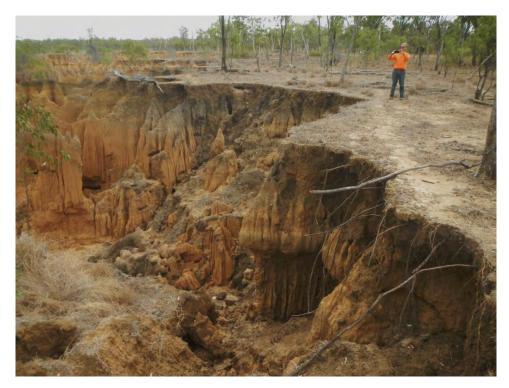
**Figure 4:** Large alluvial gully complex along Parrot Ck, a tributary entering the Bowen River just downstream of the Bowen Development Rd

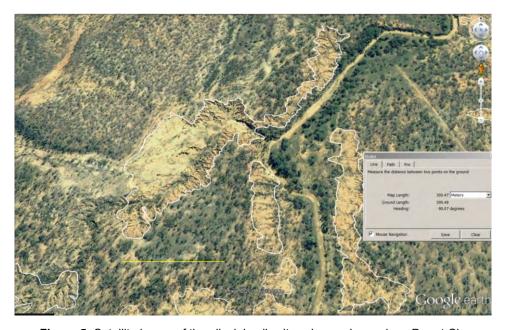
Figure 5: Satellite image of the alluvial gully sites shown above along Parrot Ck.

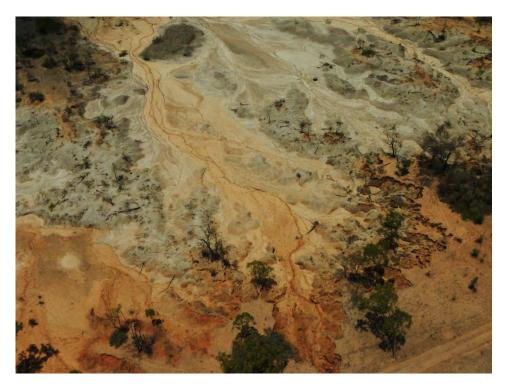
**Figure 6:** An extremely active alluvial gully system in the vicinity of the Bowen/Burdekin junction (note farm track in bottom right of picture for scale).

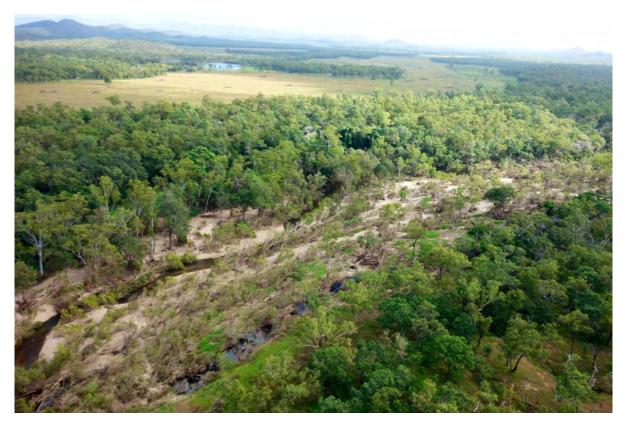
**Figure 10:** East Normanby River in the immediate aftermath of the flood generated by Cyclone Ita (photo Tim Hughes)

Insights into why the channel erosion processes differ so markedly between the two periods are more apparent from the flow data from the Laura and Normanby Rivers, given that channel processes are influenced more by the magnitude and duration of individual flood events than total annual rainfall. Interestingly, secondary channel bank erosion rates are significantly lower than the earlier period (36% on average compared to the previous period), while bed erosion rates for the same secondary channels have increased 8 fold on average (**Table 4**), albeit with one extreme outlier in Block 10 on Kings Plains station. Main channel bank erosion has also increased significantly in the second period by a factor of 2.3 on average, while main channel bed erosion increased on average by a factor of 6.5. The changes in the extent of erosion in the main channels likely reflect the impacts of larger floods generated by Cyclones Oswald and Ita in particular (**Figure 10**). It is interesting to note, however, that whilst the cyclone Ita flood was the second largest flood on record in the East Normanby River, and significant mobilisation of the bed was evident, due to the extent of riparian vegetation within the channel it is remarkable how little erosion resulted from this flood.

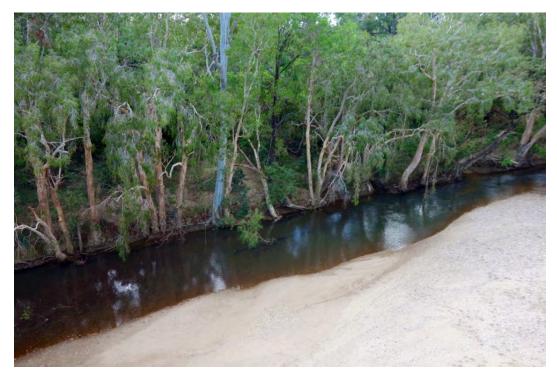
**Figure 11:** Close up of channel bank in the east Normanby River in the immediate aftermath of Cyclone Ita showing how little bank erosion occurred during this large event due to the dense riparian vegetation (photo Tim Hughes).

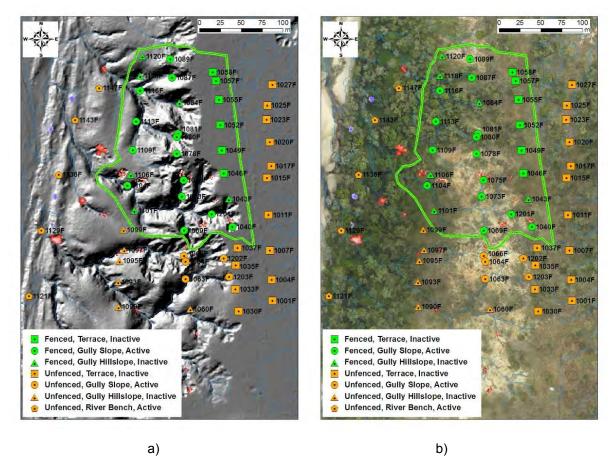
**Figure 14:** West Normanby River below the Cooktown Highway (-15.762320°S, 144.976602°E) showing a) the location of the fenced cattle exclusion area and vegetation plots with a LiDAR background and b) the location of the fenced area and vegetation plots with an aerial photo background. Note that red areas in **Figure 14**a are zones of active gully erosion between 2009 and 2011 repeat LiDAR.

A full description of the methods can be found in Appendix B and Shellberg and Brooks (2013). The layout of the vegetation plots sampled can be seen in **Figure 14**.

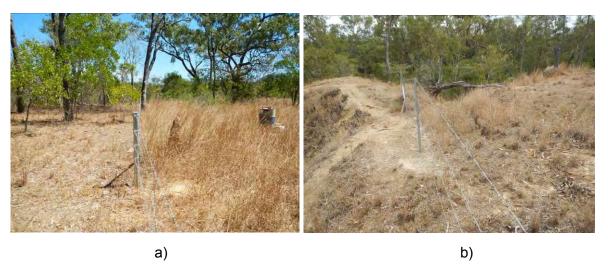
**Figure 18**: Differences in pasture yield and grass biomass inside (right) and outside (left) the West Normanby cattle exclusion fence on a) the high terrace (left picture) and b) inactive gully slopes (right picture).

Point measurements of scour and fill (± 5mm) at permanent vegetation plot reference stakes between 2011 and 2015 indicated much variability, but no clear trends (**Figure 18**). The spread of the data increased over time due to ongoing erosion and deposition at the most active gully sites. Longer-term data will be needed to understand trends from rainfall and runoff variability, and gully evolution at the site scale.

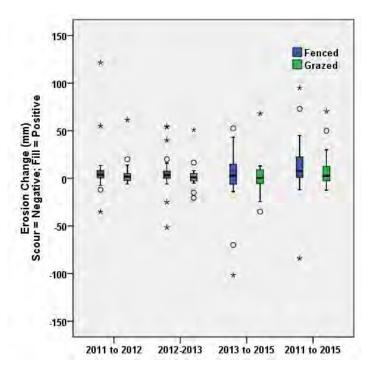
**Figure 19:** Measurement distributions of scour (negative) or fill (positive) at permanent vegetation plot reference stakes, accurate to 5mm, for fenced and grazed areas of the West Normanby gullies between 2011 and 2015.

These preliminary data display the usefulness of a before-after, control-impact (BACI) study design to begin understanding potential changes over time from land management actions (e.g., cattle fencing). The chosen metrics appear to be picking some changes in pasture condition with management of cattle over short-time periods (2011-2015), especially on high terrace catchments above gullies, but less so inside gullies. However, the year to year and seasonal variability in rainfall appears to be overriding any influences of grazing, especially during dry years with below normal rainfall (e.g., O'Reagain and Bushell 2011). Longer term datasets (+10 years) will allow for the robust statistical analysis of these datasets, in order to fully assess changes and the potential for cattle exclusion, natural resilience and recovery potential to have any influence on vegetation cover above or within gullies and gully erosion yields.

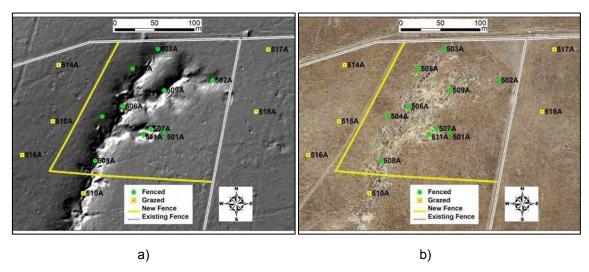
**Figure 20:** Maps of the cattle exclusion fence in the 'Old Hay Paddock' at Crocodile Station (-15.710042° S; 144.679232° E) with a) LiDAR hillshade background and b) aerial photograph background showing locations of vegetation monitoring points inside and outside the exclusion area.

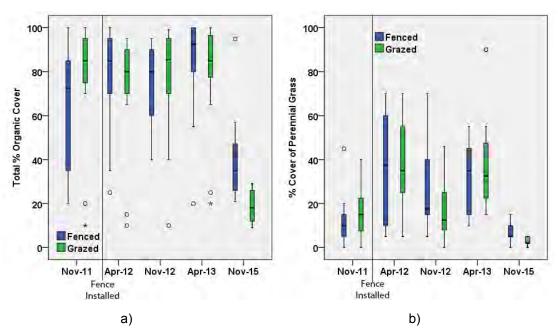
**Figure 21:** Changes in ground cover in cover inside and outside the Crocodile Station 'Old Hay Paddock' cattle exclusion site from 2011 to 2015 showing a) total % organic cover (grass, weeds, leaves, sticks, mulch) and b) % grass cover (standing perennial or annual grass).

Before the fence was installed, the % perennial grass cover was greater outside the proposed fence area than inside. Over time and after the fence was installed, this pattern shifted, with the median % perennial grass cover greater inside the fence than outside between Apr-12 and Nov-15 (Figure 21b). Increases in both grass and weed cover were quickly observed inside the fenced area between Nov-11 and Nov-12 (Figure 22ab), with less detectable changes outside (Figure 22cd). The below average rainfall in 2015 dramatically reduced the perennial grass cover both inside and outside the fence (Figure 21). However, the grass cover inside the fenced area remained elevated compared to outside even in dry conditions (Figure 21b; Figure 23).

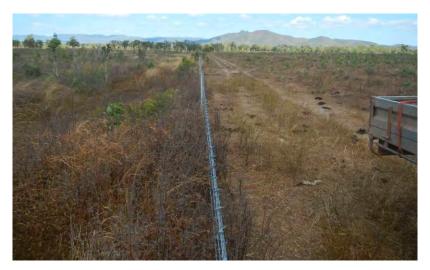
Figure 23: Grass and weed cover inside the cattle exclusion fence (left) and outside (right) in June 2015.

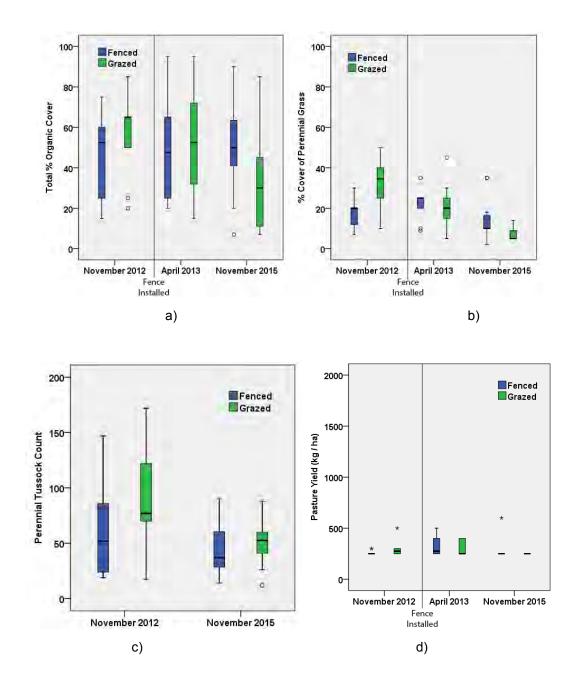
**Figure 25:** Changes in ground cover inside and outside the Granite Normanby cattle exclusion site from 2012 to 2015 showing a) total % organic cover (grass, weeds, leaves, sticks, mulch), b) % cover of perennial grass, c) perennial tussock count, and d) pasture yield (kg/ha).

Before the fence was installed, the % perennial grass cover was greater outside the proposed fence area than inside (**Figure 25**b). Over time and after the fence was installed, this pattern shifted, with the median % perennial grass cover greater inside the fence than outside in Apr-13 and Nov-15 (**Figure 25**b). Increases in grass cover were quickly observed inside the fenced area on high terrace flats between Nov-12 and Apr-13 (**Figure 25**b; **Figure 27**), whereas perennial grass cover actually decreased in the grazed area by Apr-13. By 2015, a very dry year and below average rainfall reduced the perennial grass cover and tussock counts overall, but the decline was greater in the grazed area than the fenced area (**Figure 25**bc).

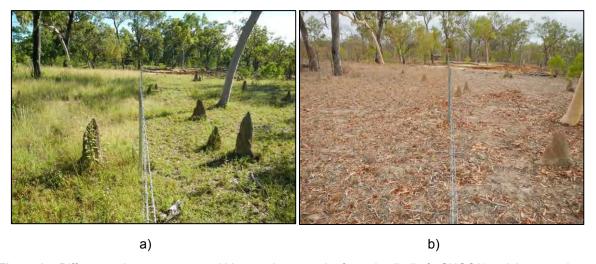
**Figure 27:** Differences in grass cover and biomass between the fenced gully (Left, GNGC6) and the grazed area (Right, GNGC9) on the high terrace of the Granite Normanby in a) April 2013 and b) November 2015.

From these data it is evident that both grazing pressure and rainfall variability can have major influences on ground and grass cover. In this case, grazing reduced total and grass cover on most geomorphic units, while cover within the fenced area remained more resilience to climate variability.

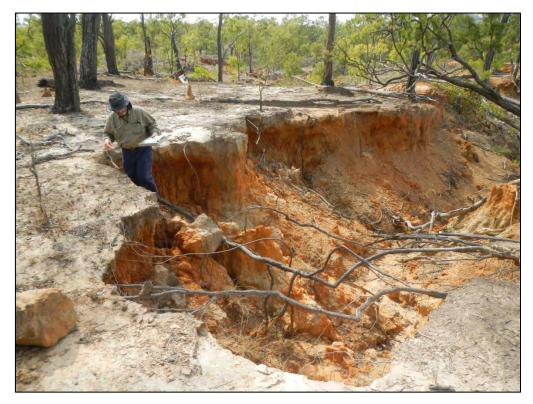
Figure 34: Example of primary gully erosion into an alluvial terrace on Springvale Station Normanby catchment

- Primary gully erosion into terrace alluvium is ubiquitous in catchments like the Normanby and Burdekin (**Figure 34**).
- Particle size significantly influences nutrient and organic content and would influence bioavailability - hence particle size fractionation should be a major consideration in future study designs.

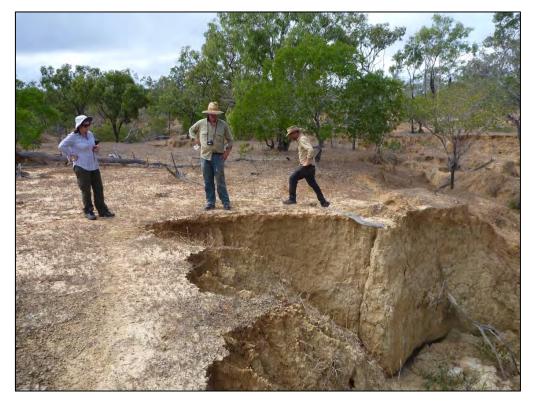
**Figure 35:** Example of secondary incision into a >50 yr old primary gully floor — Springvale Station — Normanby catchment

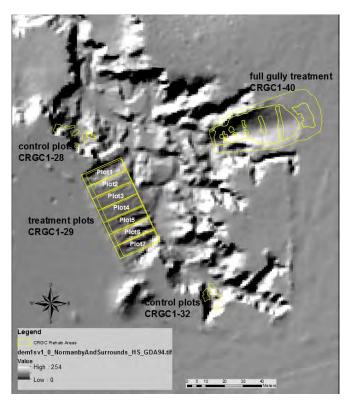
**Figure 36:** Aerial LiDAR DEMs of the Crocodile Station gully rehabilitation trial site with the rehabilitation trials plots overlaid on the 2009 DEM (LHS) (before treatment) and the 2015 DEM (RHS) 4 years post-treatment.

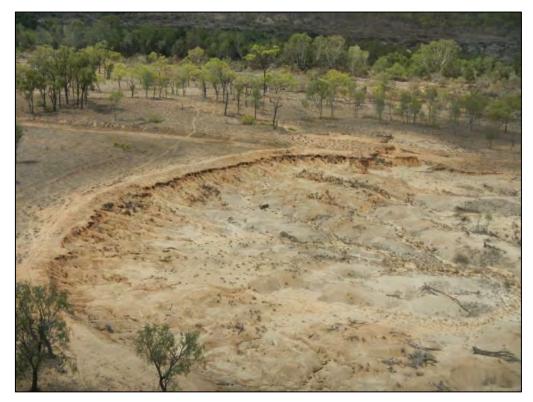
**Figure 37:** Example of a regraded alluvial gully in the Bowen catchment of unknown age with a constructed berm to exclude overland flow from the gully and with no soil treatment. This is the equivalent of the plot 1 control site in which the gully is regraded with only direct rainfall driving high levels of ongoing erosion.

Aerial LiDAR DEMs of the experimental plots before treatment and after 4 years post-treatment are shown in **Figure 36**, while a summary of the treatments is shown in **Figure 37** and a more detailed description of the plot treatments is shown in **Table 8**. Also shown in **Figure 37** are the treatment plots as they looked immediately post-construction, after the first wet season and then after 4 wet seasons.

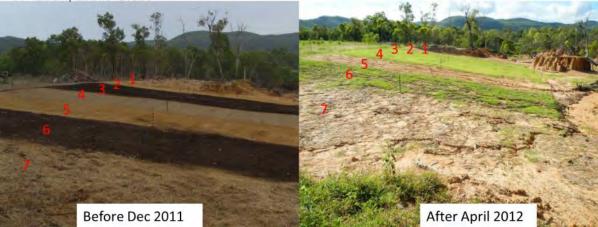
**Figure 38:** Photos of the treatment 7 x 25m 12% slope plots at the time of implementation in December 2011 and after the first wet season in 2012, and after 4 wet seasons in 2015.

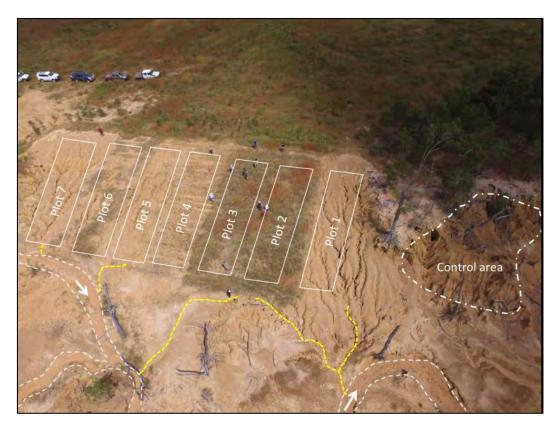
**Figure 39:** Oblique aerial photograph of the Crocodile trial plots with the control area (CRGC1-28) to the right (note the actual areas used for control erosion measurements are smaller plots within the area indicated. Note people/vehicles for scale (photo: John Brisbin).

these results. From **Figure 39** it is evident the plot most influenced by the base level controlled rill erosion is plot 7, with plots 6 and 5 also potentially influenced, as well as plot 1. However, the fact that these sites have maintained similar trajectories to those established in the earlier two surveys, would tend to suggest that the effect of any base level influence is not alone sufficient to have dominated the most recent erosion patterns and rates at the plots. The initial patterns and degree of erosion in 2012 were dominated by the treatment measures and the initial rilling that recent erosion was contingent on. At most, base level influence will have altered the relative degree of difference between the most effective treatments (plots 2-4) compared to the control site with no soil treatment (plot 1) and the other external controls.

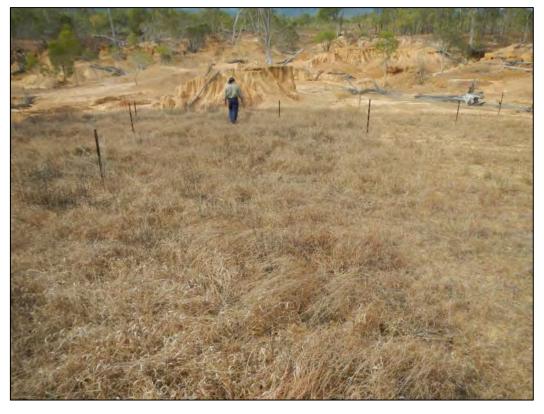
**Figure 40:** Remnant gully pedestal immediately downslope from plot 3 in June 2015, which is potentially buffering base level lowering downslope from plots 2-4 to a greater extent than the other plots.

- Over time the erosion results became more influenced by the antecedent base-level conditions of each plot despite being shaped equally at the start. Coincidentally, the most successful plots were buffered from base level control by a remnant pedestal, while the least successful were partially influenced by gully channel bank erosion in the larger gully complex. Ongoing analysis of these plots is not recommended after this 4 year period due to this confounding factor.
- Great care must be taken to ensure gully base level is adequately controlled during gully slope stabilization, otherwise treatments can be undermined by downstream base level controls.
- When scaling these treatments up to the whole of gully scale, a range of additional controls on gully floor incision will need to be applied in concert to ensure secondary incision doesn't occur.

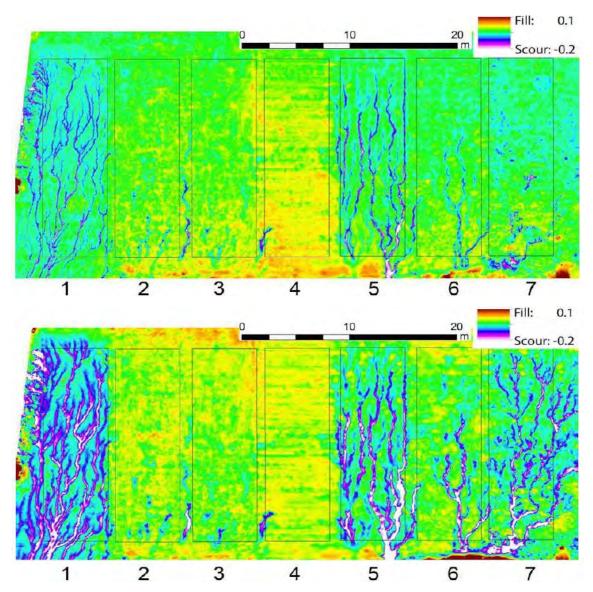
**Figure 41:** DEM of Difference from 2012 (top) and 2013 (bottom); i.e. after one and two wet seasons respectively from Shellberg and Brooks (2013). Note that the images are presented in mirror to their actual orientation on the ground for ease of visualisation.

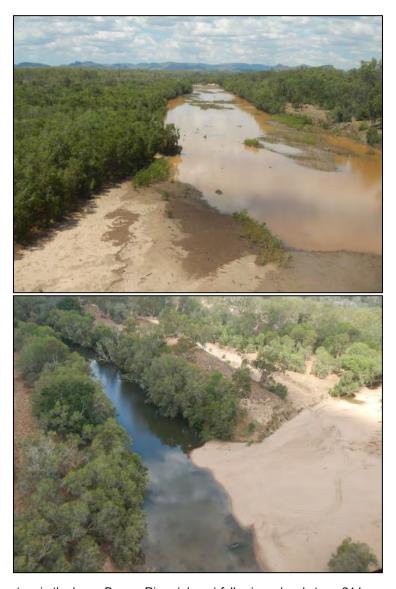
**Figure 50:** Turbid waters in the lower Bowen River (above) following a local storm 24 hrs earlier, while the river several km upstream, which was unaffected by the storm, remains clear (below). The area impacted by the storms has numerous highly connected alluvial gullies which deliver high suspended sediment loads directly to the Bowen main stem channel almost instantaneously upon receiving rainfall.

The connectivity of the alluvial gully sediment sources was graphically demonstrated when an early wet season storm hit the area in November 2015 causing the river to become highly turbid almost instantaneously (**Figure 50**). By comparison, sections of the river immediately upstream, which were unaffected by the storm cells, were running clear. Clear water flow is the typical scenario for the dry season base flows in this part of the Bowen River.

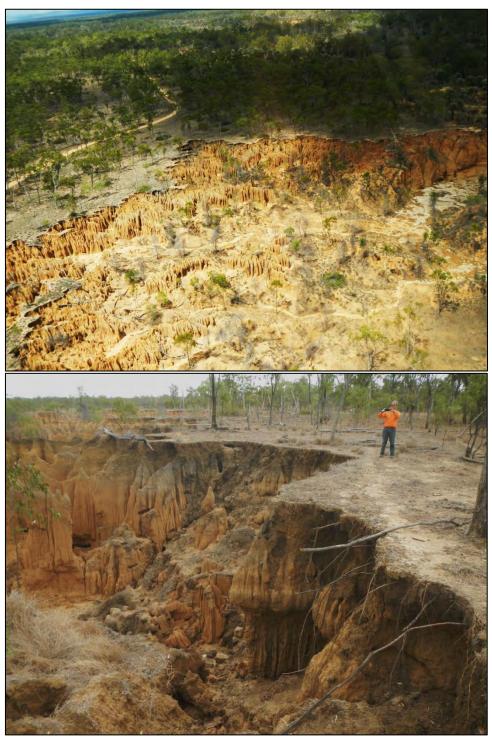
**Figure 51:** Large alluvial gully complex along Parrot Ck, a tributary entering the Bowen River just downstream of the Bowen Development Rd

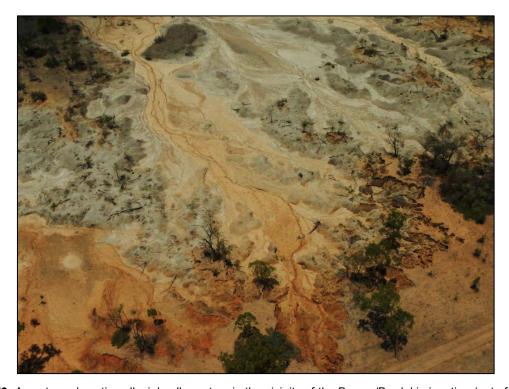
**Figure 53:** An extremely active alluvial gully system in the vicinity of the Bowen/Burdekin junction (note farm track in bottom right of picture for scale).

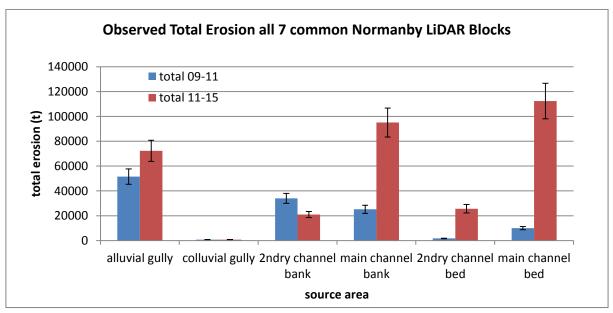
**Figure A4:** Summary data of total erosion from the two periods for which minimum erosion rates have been determined from aerial LiDAR data. Error bars represent the standard error between the 7 blocks at the total block scale.

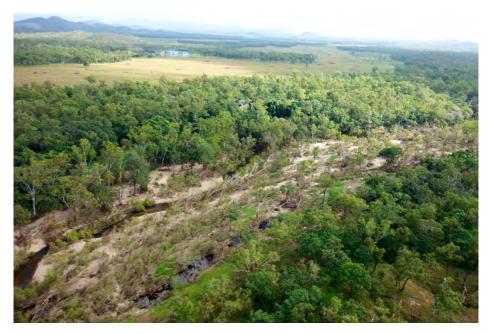
**Figure A7:** East Normanby River in the immediate aftermath of the flood generated by Cyclone Ita (photo Tim Hughes).

The situation for channel erosion is quite different to that with gullies, for which we would not expect to find a direct relationship between annual incident rainfall and channel erosion, given that channel erosion is a threshold driven process, which is influenced more by the magnitude and duration of flow events, rather than total annual rainfall. Interestingly, secondary channel bank erosion rates are significantly down on the previous period (0.36 on average), while bed erosion rates for the same secondary channels have increased 8 fold on average (Table A2) albeit with one extreme outlier in Block 10 on Kings Plains station. Main channel bank erosion has also increased significantly in the second period by a factor of 2.3 on average, while main channel bed erosion increased on average by a factor of 6.5. The changes in the extent of erosion in the main channels likely reflects the impacts of larger flows generated by Cyclones Oswald and Ita in particular (Figure A7, Figure A9, Section 4). It

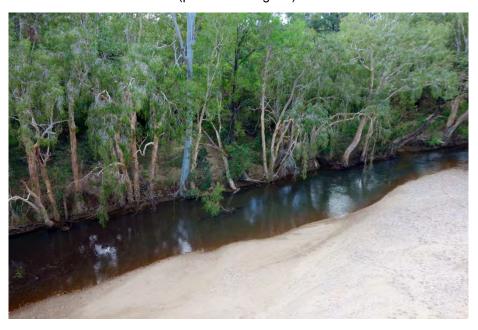
**Figure A8:** Close up of the lower bank of the East Normanby River in the immediate aftermath of Cyclone Ita, indicating how little bank erosion there was in general as a result of this large flood.

is interesting to note, however, that whilst the cyclone Ita flood was the second largest flood on record in the East Normanby River, and significant mobilisation of the bed was evident, due to the extent of vegetation within the channel it is remarkable how little erosion resulted from this flood (Figure A8).

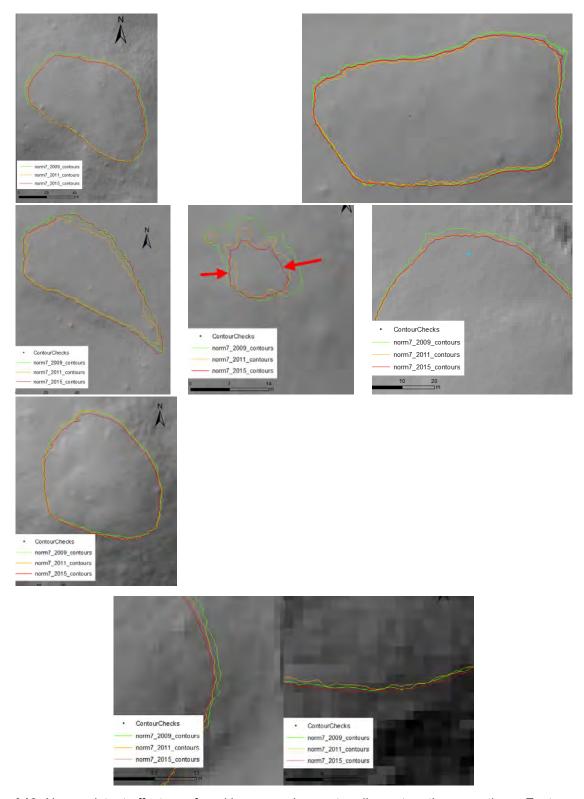
**Figure A13:** No consistent offset was found by comparing contour lines at northern, southern, Eastern or western aspects of slopes.

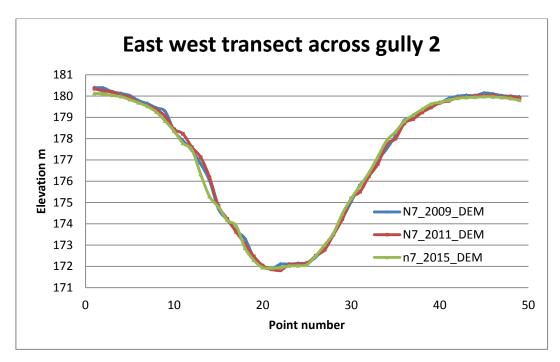
In Gully 2 it is hard to see any obvious problems in the curves. Efforts to correct the "offset" as seen in the difference layer cause the positive and negative values to flip to opposite sides of the gully.

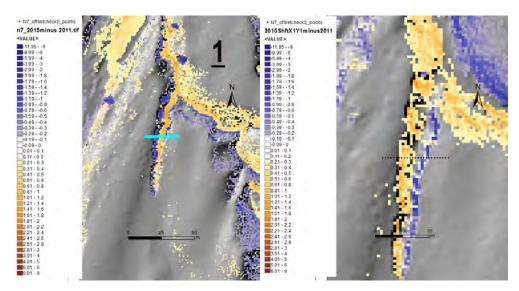
Shifting 2015 DEM 1m to the right flipped the side of gully with erosion values from left to right. Panel on right has raster shifted 1m to the east.

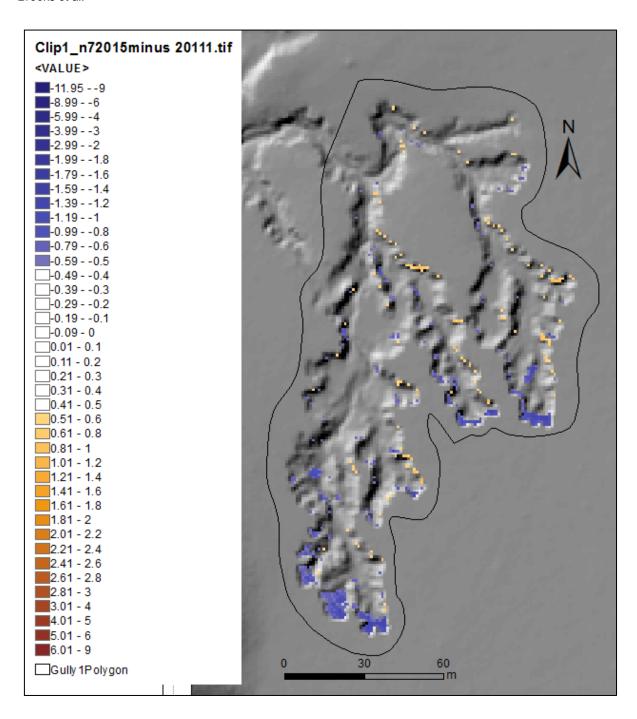
All of Normanby 7 with difference layer 2015-2011 with values between 0.5 and -0.5m masked, i.e. same noise filter as previously.

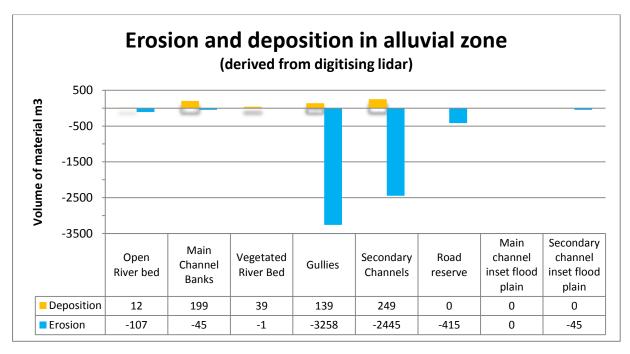
**Figure A31:** Large volumes of erosion came from gullies and secondary channels. The contribution from road drainage, 415 m<sup>3</sup> was on a par with the second largest producing unit in Norm 4, a 700m section of secondary channel with active bank erosion.

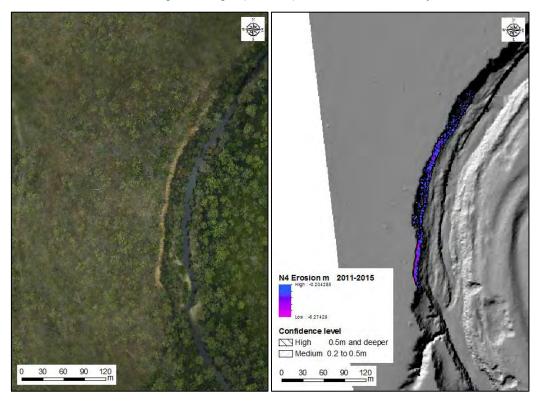
**Figure A38:** The largest patch of erosion that was not bedload was from this 11m tall bank on the East Normanby main channel, with a volume of 23,754m<sup>3</sup>.

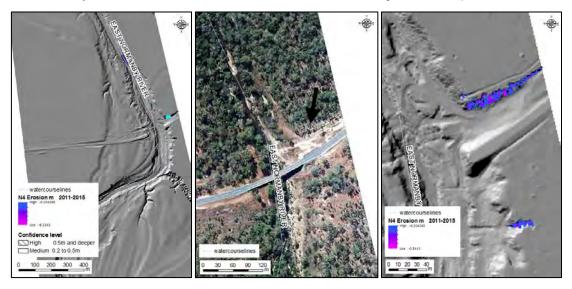
**Figure A42:** Fourth largest patch of erosion into ancient flood plain is associated with a road crossing the East Normanby, volume of erosion was 355m<sup>3</sup> in total.

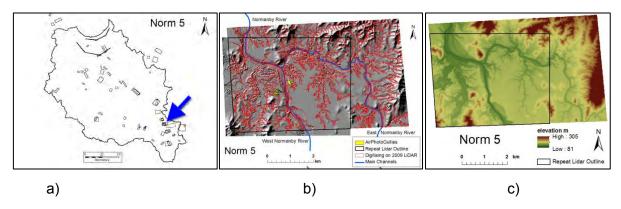
Figure A46: a) N5 location; b) Digitising on 2009 LiDAR; c) 2009 DEM.

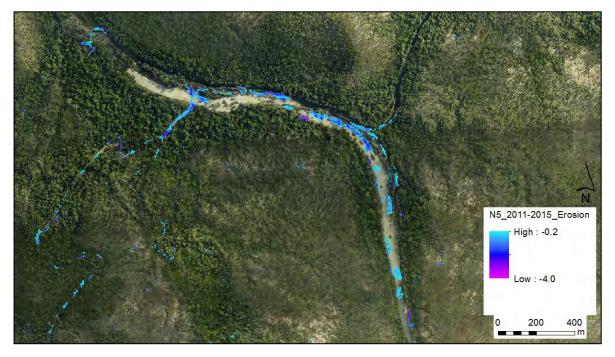
Figure A59: Erosion in main channel and secondary stream with orthophoto from 2009.

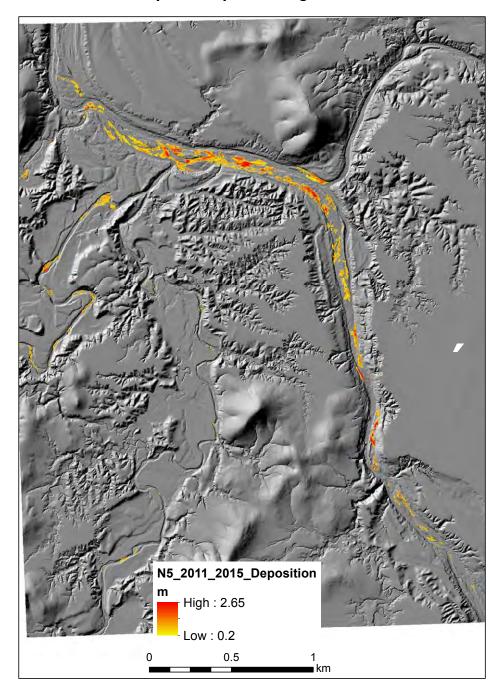
Figure A66: Patterns of deposition in N5 between 2011 and 2015.

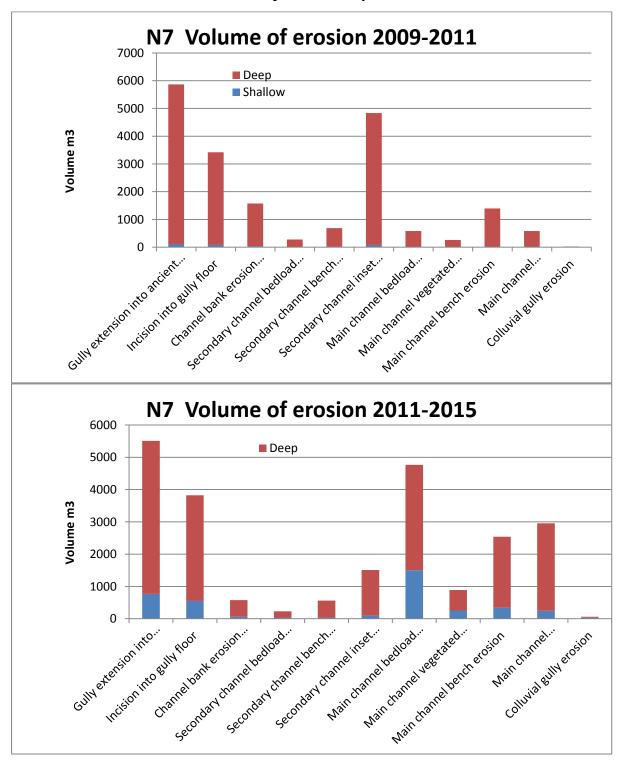
Figure A74: Erosion stats for Block 7 by geomorphic unit 2009-11 (top); 2011-15 (bottom).

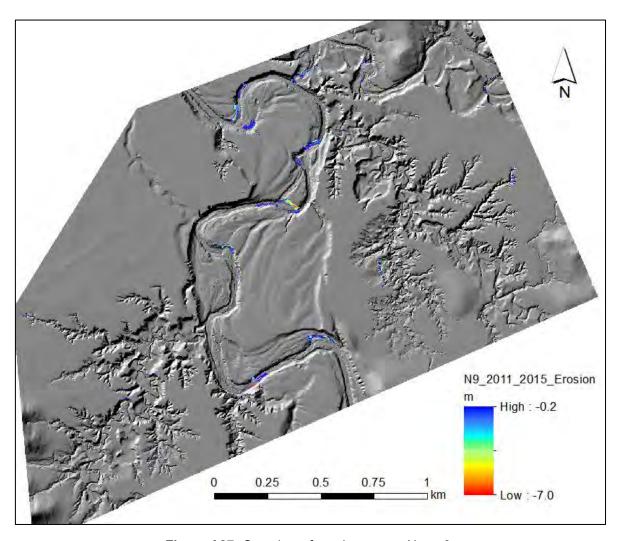
Figure A87: Overview of erosion across Norm 9.

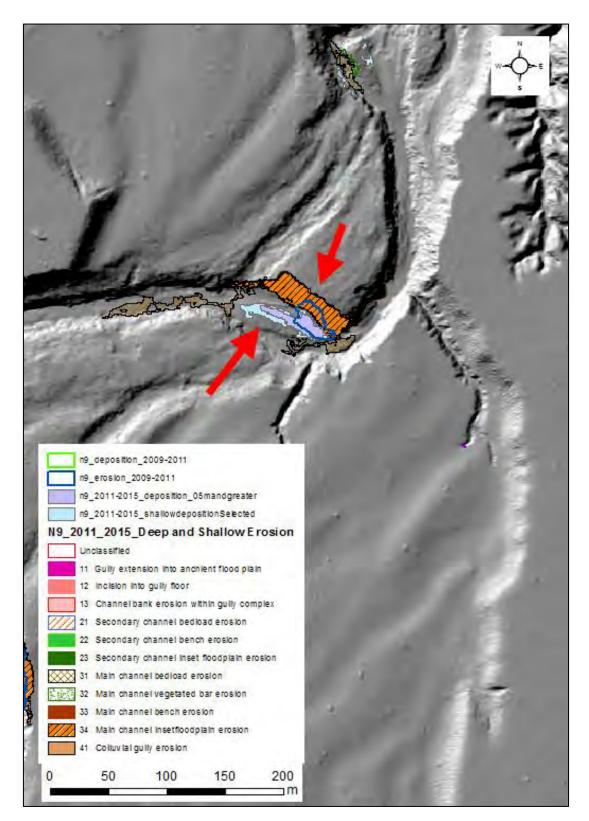
**Figure A91:** A smallish erosion patch, seen as blue outline, between 09-11 expanded between 11-15. The bar in mid channel has received deposits in both time steps.

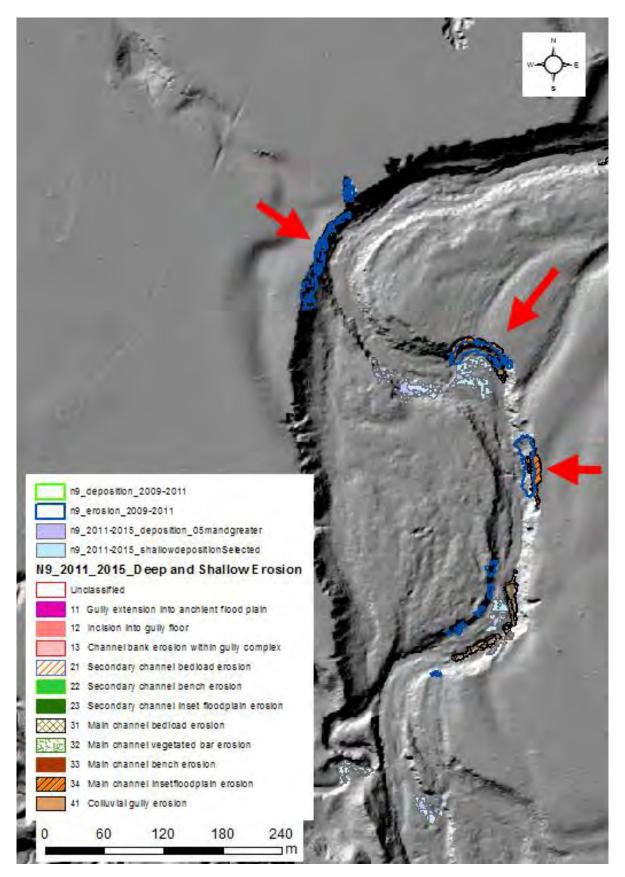
**Figure A92:** On the east side of the East Normanby two sites continued eroding during the 11-15 time step. Erosion on the high bank on the outside of the bend was less between 11-15 than 09-11.

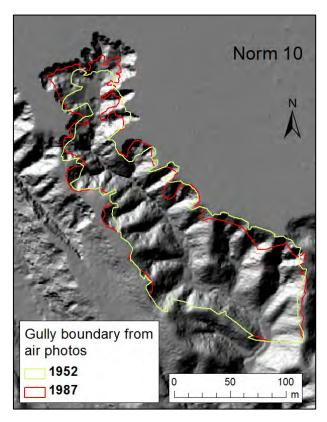
**Figure A104:** Gully perimeter in 1952, 1987 and 2009. Variability in rates of erosion over different time scales was found, with the rate over 5 decades from 1950s to 2009 being 81 m<sup>2</sup>/ha/yr; over 2 decades from 1890's being 170 m<sup>3</sup>/ha/yr, and over 2 years from 2009 to 2011 being 104 m<sup>3</sup>/ha/yr.

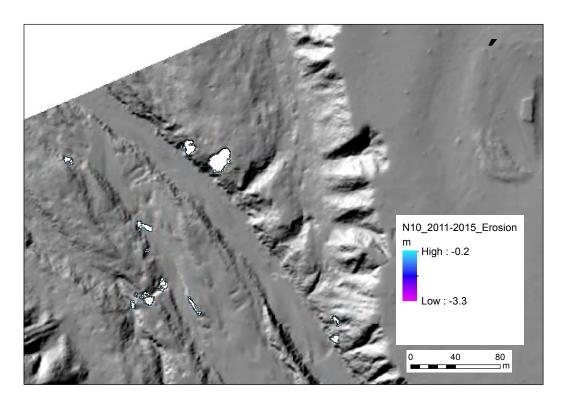
**Figure A114:** Example of a bank mass failure – which are a fairly rare phenomenon in the Normanby.

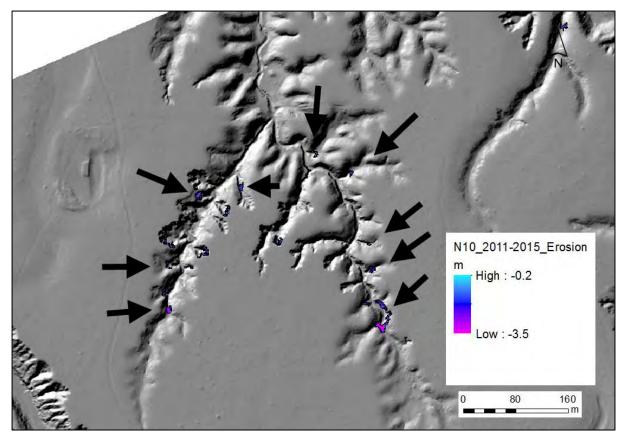
Figure A115: Plenty of examples of reworking of an existing gully floor.

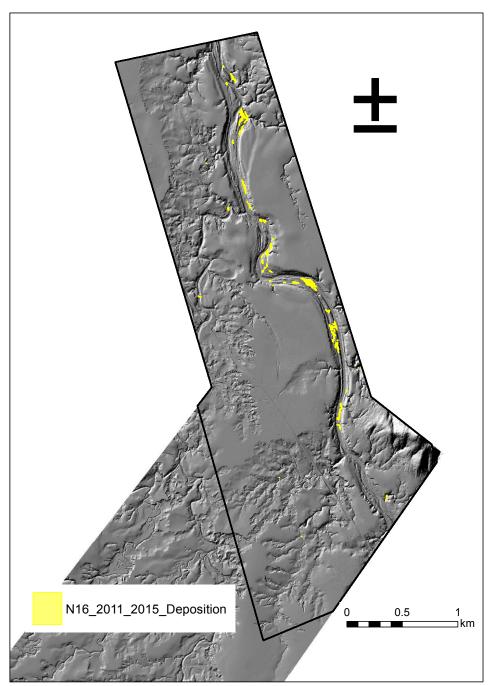
Figure A129: Patterns of deposition in N16.

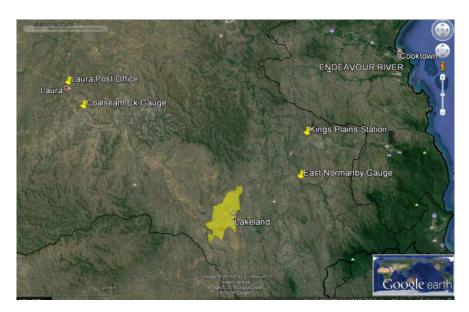
**Figure A135:** Map of the upper Normanby River showing the locations of the 4 sites for which monthly or daily rainfall records are derived.

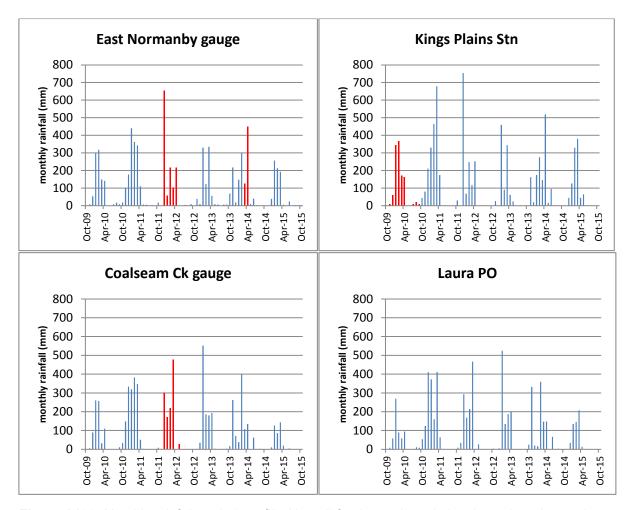
Figure A136: Monthly rainfall totals (gap-filled in red) for the study period at the 4 sites shown above.

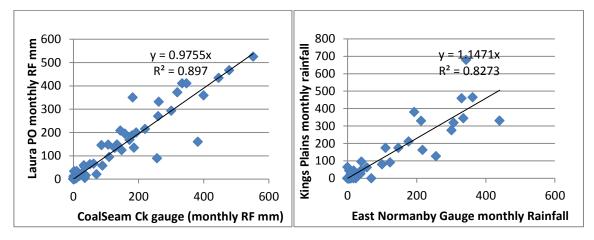
**Figure A137:** Correlations between monthly rainfall totals at the Coalseam Ck gauge and the Laura Post Office and the East Normanby gauge site and Kings Plains Station. These relationships were used to fill missing data in the gauge records.

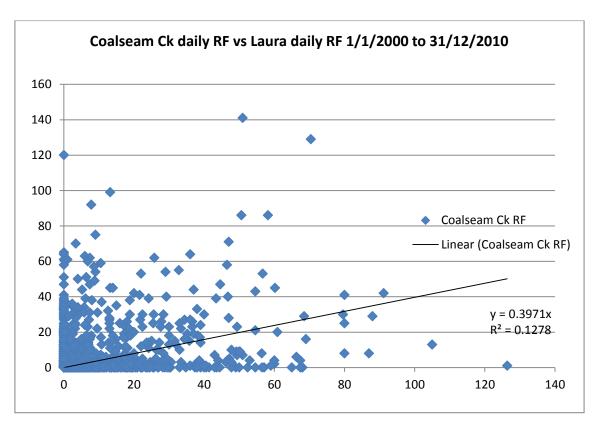
**Figure A138:** Correlation between daily rainfall at Coalseam Ck with Laura Post Office over the last 10 years (missing data days removed).

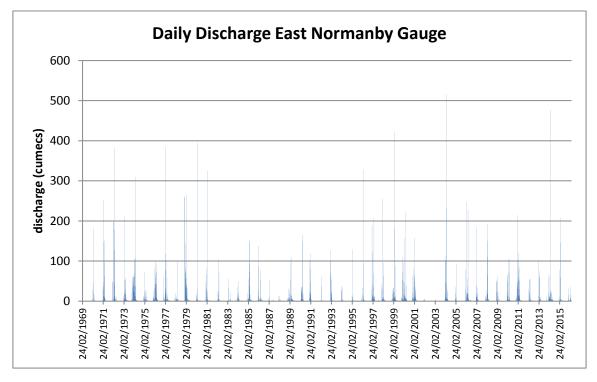
Figure A139: Mean Daily discharge for the period of record at East Normanby River

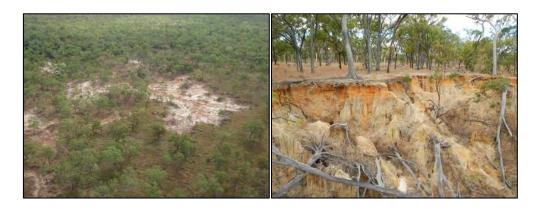
**Figure B1:** Examples of alluvial gullies in the Normanby catchment.

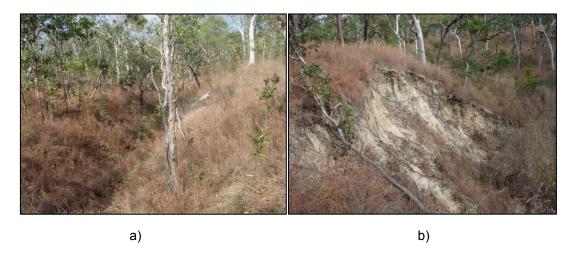
**Figure B3:** Examples of improved cover of native kangaroo grass (*Themeda triandra*) following 10 years of cattle and fire exclusion on a) rounded gully slopes, and b) a gully scarp with only modest cover improvements compared to surrounding uneroded soils (middle Annan River).

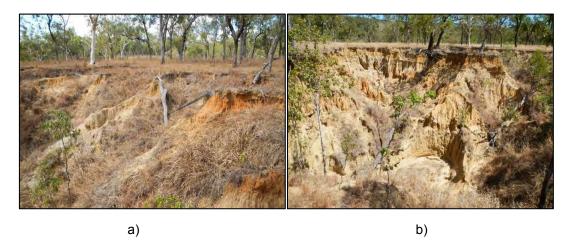
**Figure B4:** Examples of improved vegetation cover at a) a gully scarp where black spear (*Heteropogon contortus*) and blady (*Imperata cylindrica*) grass cover have increased slightly following 2 years of cattle exclusion and b) a large gully scarp where grass cover improvements have been fairly isolated to gully floors, slumped soil blocks, and intact slopes (Normanby River at Kings Plains).

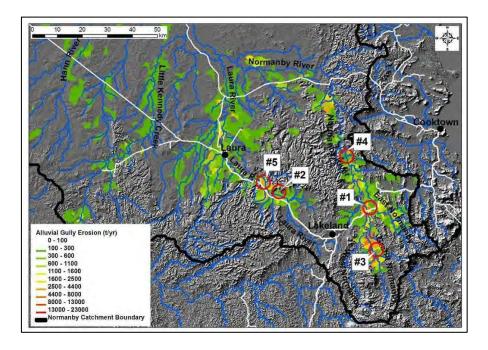
**Figure B5:** Distribution of sub-catchments with significant alluvial gully erosion (tonnes/year/subcatchment) in the Laura-Normanby catchment (from Brooks et al. 2013), and locations of fenced cattle exclusion experimental sites, #1) West Normanby (-15.762320°S, 144.976602°E), #2) Crocodile Paddock (-15.710042°S, 144.679232°E), #3) Granite Normanby (-15.896374°S, 144.994678°E), #4) Normanby River mainstem at Mosquito (-15.598804°S, 144.916466°E), #5) *proposed* at Laura River at Crocodile Gap (15.668992°S, 144.592765°E).

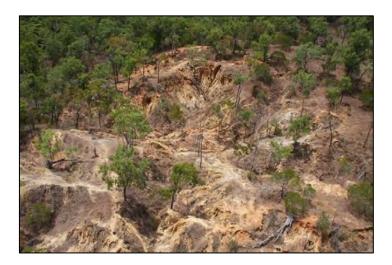
**Figure B6:** Aerial view (Nov-2011) of the West Normanby gully complex where cattle exclusion started in September 2012. Note network of pre-existing cattle trails on gully ridges and valleys.

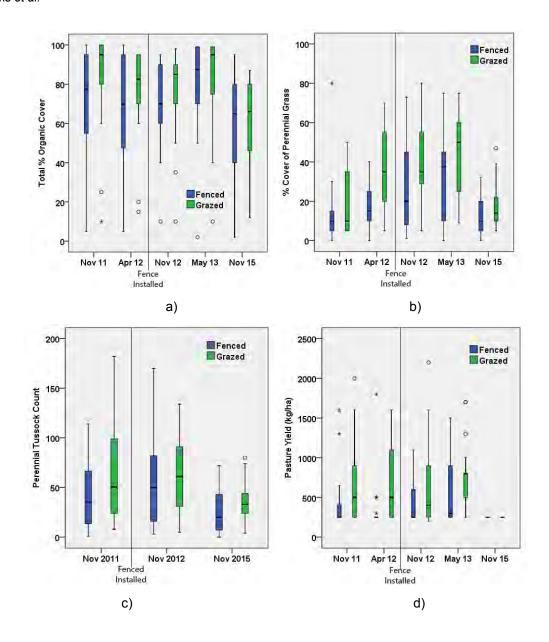
**Figure B8:** Changes in ground cover inside and outside the West Normanby cattle exclusion site from 2011 to 2015 showing a) total % organic cover (grass, weeds, leaves, sticks, mulch) and b) % perennial grass cover, c) perennial grass tussock count, and d) pasture biomass yield.

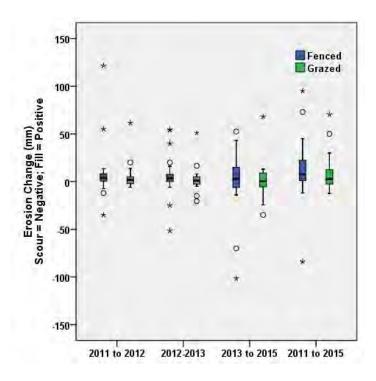
**Figure B12:** Measurement distributions of scour (negative) or fill (positive) at permanent vegetation plot reference stakes, accurate to 5mm, for fenced and grazed areas of the West Normanby gullies between 2011 and 2015.

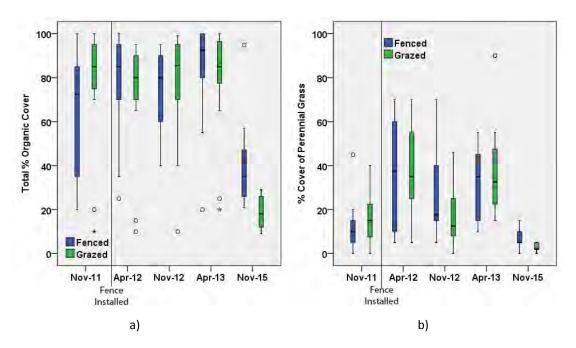
**Figure B15:** Changes in ground cover in cover inside and outside the Crocodile Station 'Old Hay Paddock' cattle exclusion site from 2011 to 2013 showing a) total % organic cover (grass, weeds, leaves, sticks, mulch) and b) % grass cover (standing perennial or annual grass).

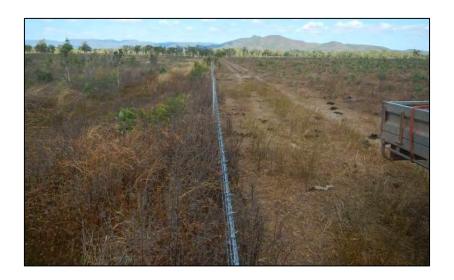
**Figure B17:** Grass and weed cover inside the cattle exclusion fence (left) and outside (right) in June 2015.

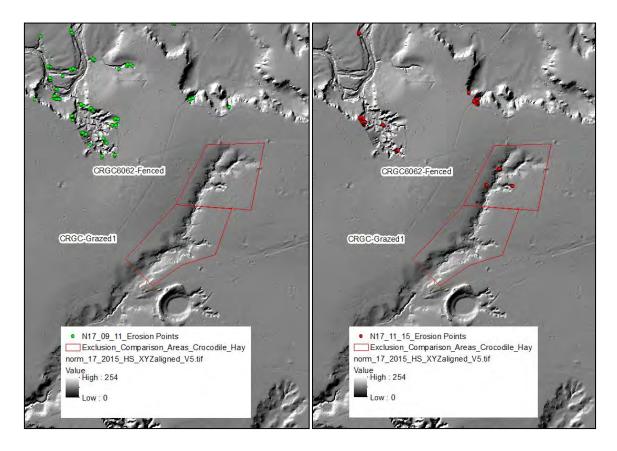
**Figure B18:** Cattle exclusion area and aerial LiDAR analysis areas (control-impact) at the Crocodile Hay Paddock in block N17 on Crocodile Station. Also shown are the locations of the polygons within which erosion was detected by aerial LiDAR in the first period in green (2009-2011, LHS), and the second period in red (2011-2015, RHS).

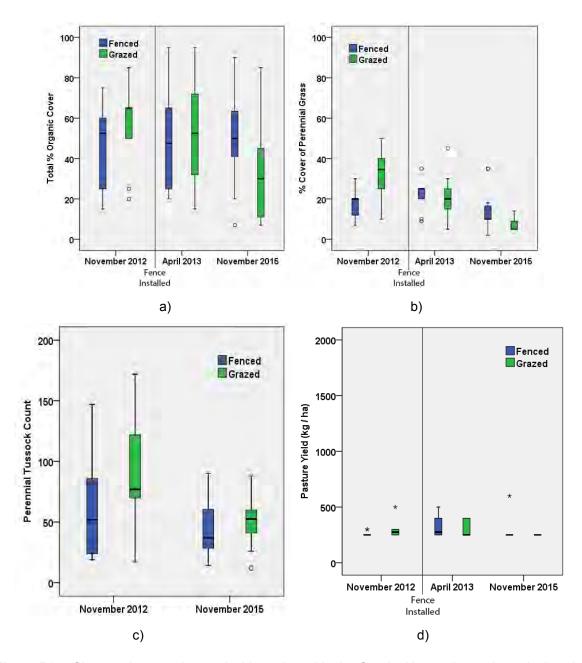
**Figure B20:** Changes in ground cover inside and outside the Granite Normanby cattle exclusion site from 2012 to 2015 showing a) total % organic cover (grass, weeds, leaves, sticks, mulch) b) % cover of perennial grass, c) perennial tussock count, and d) pasture yield (kg / ha).

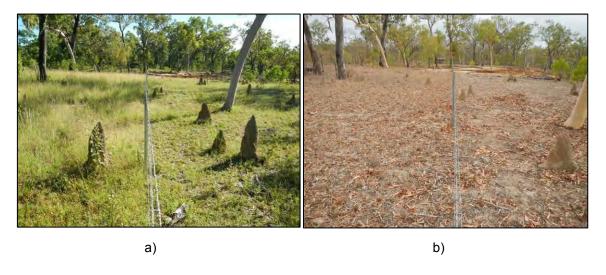
**Figure B22:** Differences in grass cover and biomass between the fenced gully (Left, GNGC6) and the grazed area (Right, GNGC9) on the high terrace of the Granite Normanby in a) April 2013 and b)

November 2015.

GNGC6 and GNGC9. However, this spelling effort was marginal and cattle continued to graze the area as indicated in Figure B22, Figure B22, and field observations. The lack of major vegetation improvements inside the fenced gully at GNGC6, compared to observed improvements on the high terrace of the gully catchment, would suggest that large-scale erosion changes should not be expected. Longer-term monitoring and more detailed datasets of surficial erosion will be needed to better quantify potential changes to grazing exclusion.

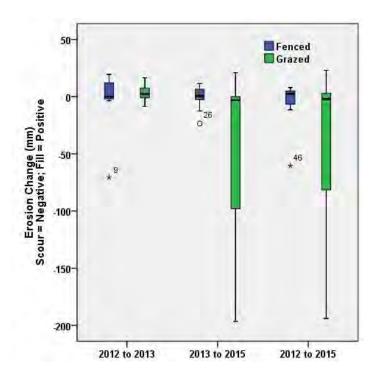
**Figure B23:** Measurement distributions of scour (negative) or fill (positive) at permanent vegetation plot reference stakes, accurate to 5mm, for fenced and grazed areas of the Granite Normanby gullies between 2012 and 2015.

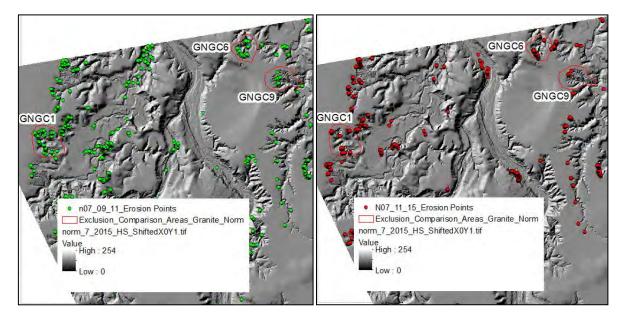
**Figure B24:** Cattle exclusion area and aerial LiDAR analysis areas (control-impact) along the Granite Normanby River in block N7 on Springvale Station. Also shown are the locations of the polygons within which erosion was detected by aerial LiDAR in the first period in green (2009-2011, LHS), and the second period in red (2011-2015, RHS).

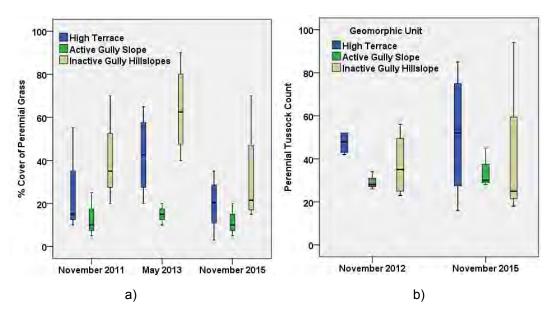
**Figure B27:** Changes in ground cover at different geomorphic units (terrace, gully, hillslope) inside and outside the Kings Plains cattle exclusion area from 2012 to 2015 showing a) % cover of perennial grass and b) perennial grass tussock counts.

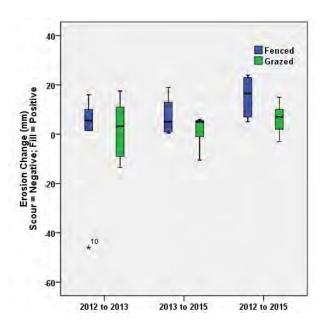
**Figure B28:** Measurement distributions of scour (negative) or fill (positive) at permanent vegetation plot reference stakes, accurate to 5mm, for fenced and grazed areas of the Kings Plains gullies between 2012 and 2015.
