# Reducing sediment sources to the Reef: Managing alluvial gully erosion

Andrew Brooks, Graeme Curwen, John Spencer, Jeff Shellberg, Alexandra Garzon-Garcia, Jo Burton and Fabio Iwashita in collaboration with Trish Butler

Brooks, A., Spencer, J., Curwen, G, Shellberg, J., Garzon-Garcia, A, Burton, J. & Iwashita, F. (2016) *Reducing sediment sources to the Reef: Managing alluvial gully erosion*. Report to the National Environmental Science Programme. Reef and Rainforest Research Centre Limited, Cairns (375pp.).

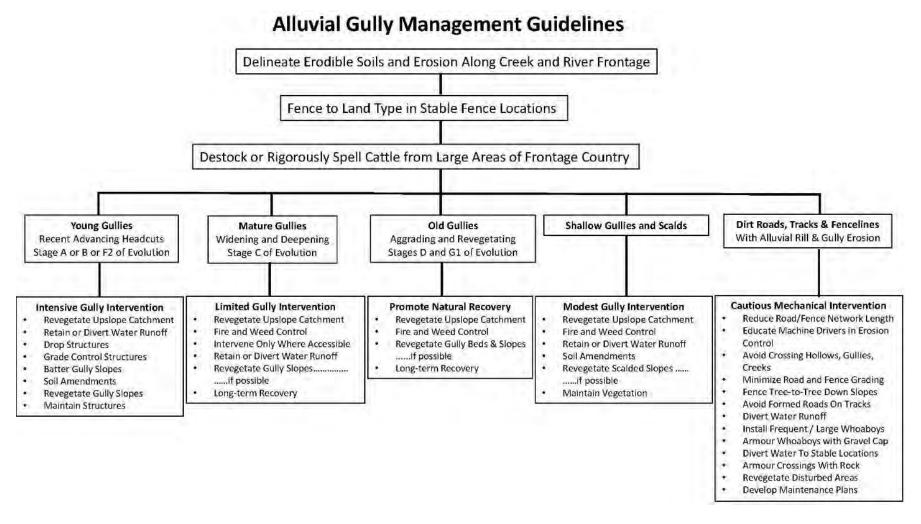
**Figure B31:** Alluvial gully management guidelines and a flow chart for potential avenues into rehabilitation, categorized by gully type and stage of gully evolution (following Gellis 1995).

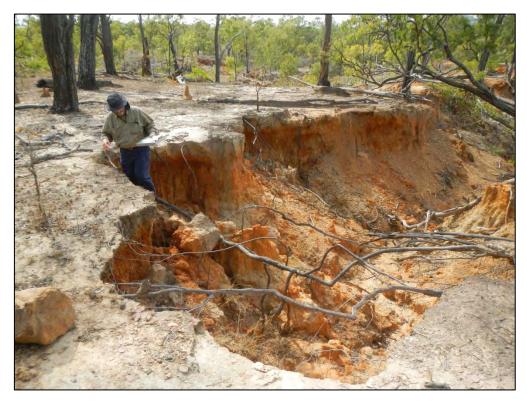
**Figure C1:** Example of primary gully erosion into an alluvial terrace on Springvale Station Normanby catchment.

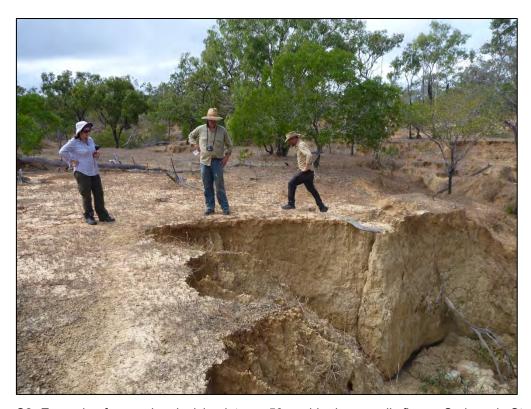
**Figure C2:** Example of secondary incision into a >50 yr old primary gully floor – Springvale Station – Normanby catchment.

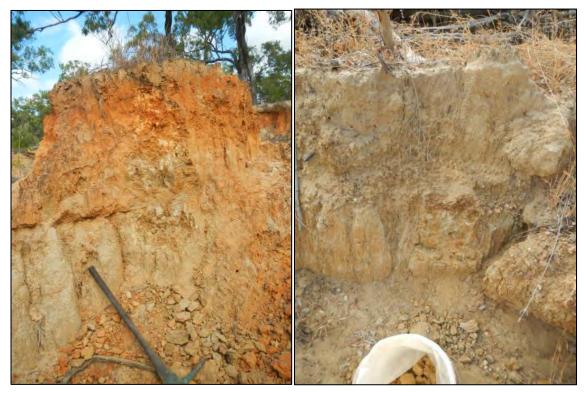
**Figure C4:** Bank subsurface geomorphic unit in the Granite Normanby alluvial gully and Laura Crocodile gap alluvial gully.

- Bank subsurface: Subsurface soil (excluding the organic A horizon), which was visually differentiated on exposed gully banks was sampled. First the gully wall was cleaned and then a sample was collected using a shovel or trowel.
- Bank (or gully wall) surface: The organic A horizon, which was visually differentiated on exposed gully banks was sampled. First the gully wall was cleaned and then a sample was collected from the gully bank surface (0-10 cm) using a trowel and spade.

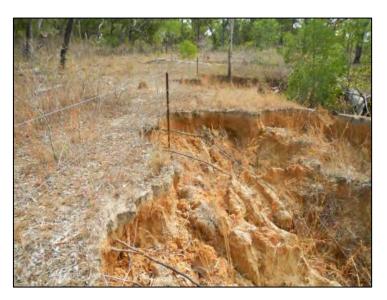
**Figure C5:** Bank surface geomorphic unit in the Granite Normanby alluvial gully (clearly differentiated by colour from the bank subsurface unit).

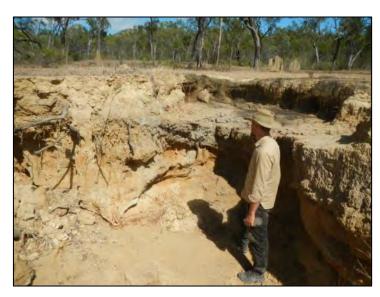
Buried A horizon: In the Crocodile Gap gully a distinct buried A horizon was sampled from the gully bank. First the sampling wall was cleaned and then a sample was collected from the buried A horizon using a trowel and spade.

Figure C6: Buried A horizon geomorphic unit in the Laura Crocodile Gap alluvial gully.

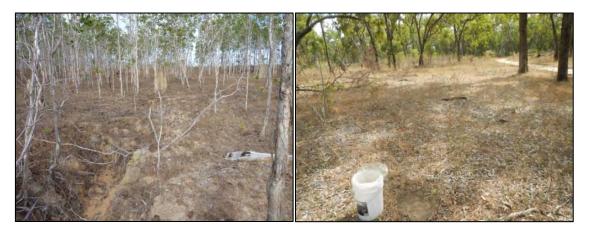
• Terrace: Alluvial gullies are developed by the erosion of previously deposited material in river terraces. Terrace surface soil samples were taken from deposits not affected by gully erosion by removing any vegetation from the surface of the soil and then collecting the surface soil (0-10 cm) using a trowel and spade. Material at these sites is assumed to represent bank surface material prior to any influence from gullying. Hence it is assumed bank/gully wall surface material will have similar characteristics as the terrace surface soil when an active gully scarp migrates through a terrace. The reason for sampling both is that the gully wall surface material is

leached and altered due to its proximity to the gully incision, and so the terrace surface material is assumed to better represent the organic and nutrient status of these soils at the time the soil is first delivered to the gully.

**Figure C7:** Terrace surface soil geomorphic unit in the Granite Normanby and Laura Crocodile station alluvial gullies.

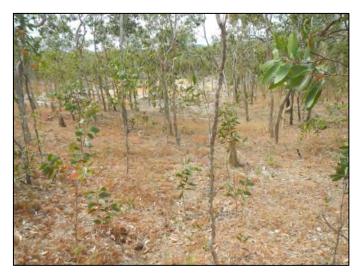
Hillslope: Hillslope gullies are distinct from alluvial gullies in that they are eroding into colluvial hillslope material. The hillslope sample was taken from intact hillslope material (not affected by gully erosion) by removing any vegetation and litter from the surface of the soil and then collecting the surface soil (0-10 cm) using a trowel and spade.

Figure C8: Hillslope geomorphic unit in the Parsons Creek hillslope gully

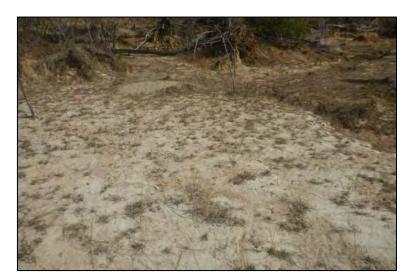
Gully floor: Deposited sediment in the bottom of gullies was sampled by removing any vegetation from the surface of the soil and then collecting the surface soil (0-10 cm) using trowel and spade.

Figure C9: Gully floor geomorphic unit in the Granite Normanby alluvial gully.

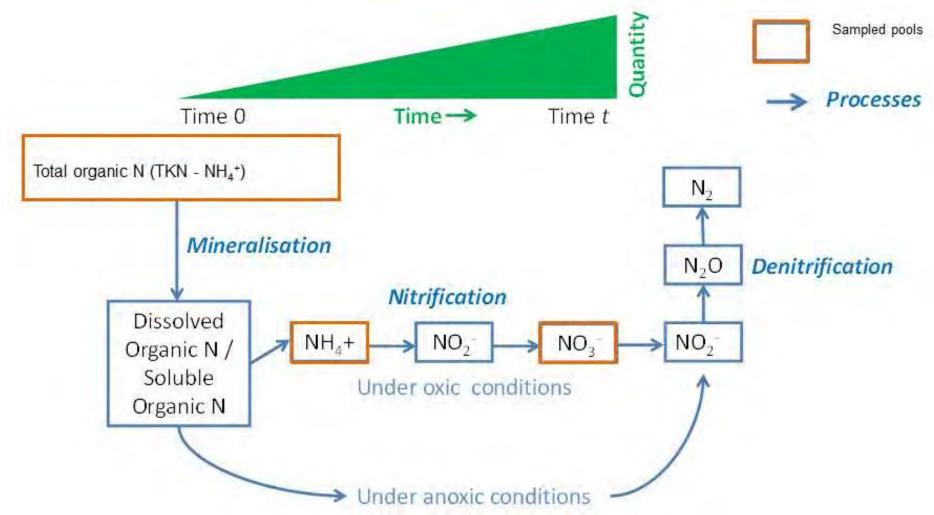
**Figure C10:** Key pools and processes of the nitrogen cycle. The trend of bioavailable nitrogen over time is indicated in the figure (Adapted from Burton et al. 2015).

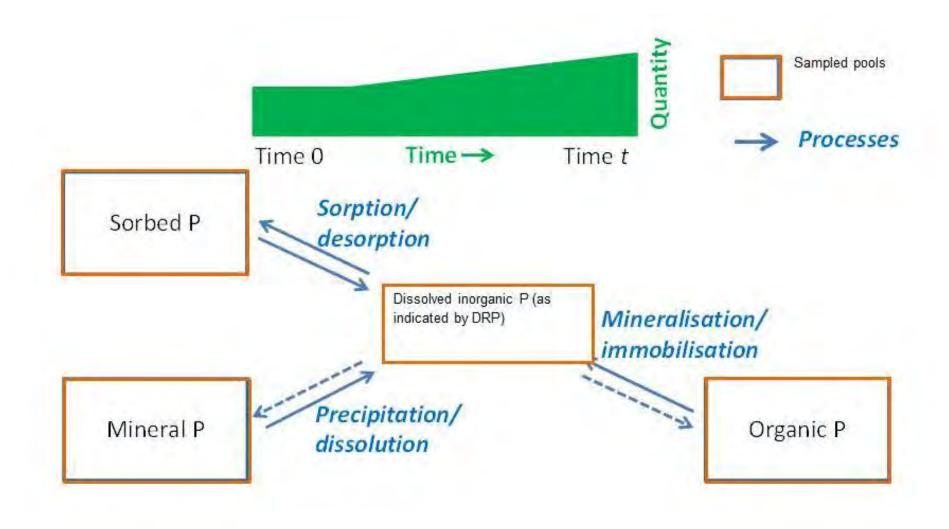
Figure C11: Key pools and processes of the phosphorus cycle. The trend of bioavailable phosphorus over time is indicated in the figure (Burton et al., 2015).

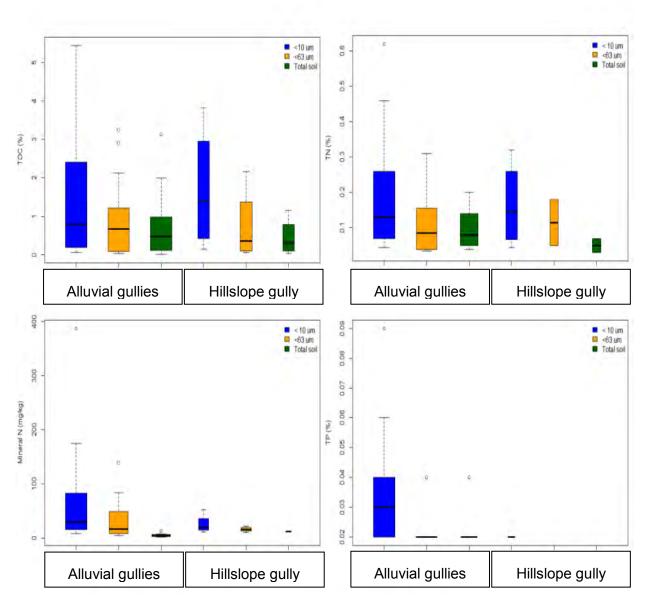
**Figure C13:** Percent total organic carbon (TOC), total nitrogen (TN), mineral N and total phosphorus (TP) in alluvial and hillslope gully soil/sediment for the total (green), <63 um (yellow) and <10 um (blue) particle size fractions. Boxes are intersected by median values and enclose data between the first and third quartiles, with lines extending to maximum and minimum values excluding outliers (values above and below 1.5 times the inner quartile range from the first and third quartiles, respectively). Box width is proportional to the square root of n for each group. Absence values indicate the parameter was non-detectable in any of the samples.

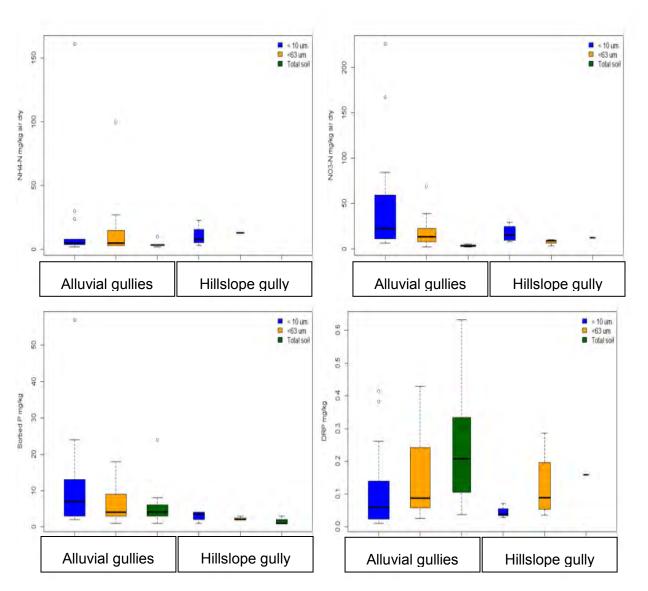
**Figure C14:** Ammonium (NH<sub>4</sub>-N), nitrate (NO<sub>3</sub>-N), sorbed phosphorus (P) and dissolved reactive phosphorus (DRP) in alluvial and hillslope gully soil/sediment for the total (green), <63 um (yellow) and <10 um (blue) particle size fractions. Boxes are intersected by median values and enclose data between the first and third quartiles, with lines extending to maximum and minimum values excluding outliers (values above and below 1.5 times the inner quartile range from the first and third quartiles, respectively). Box width is proportional to the square root of n for each group. Absence values indicate the parameter was non-detectable in any of the samples.

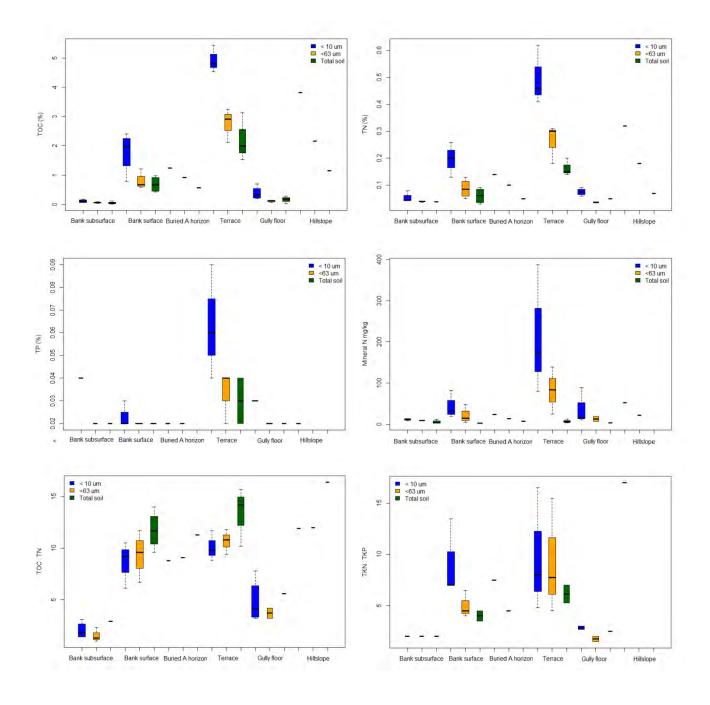
**Figure C15:** Percent total organic carbon (TOC), total nitrogen (TN), total phosphorus (TP), mineral N (mg/kg),TOC:TN ratio and TN:TP ratio by gully geomorphology component for the total (green), <63 um (yellow) and <10 um (blue) particle size fractions. Boxes are intersected by median values and enclose data between the first and third quartiles, with lines extending to maximum and minimum values excluding outliers (values above and below 1.5 times the inner quartile range from the first and third quartiles, respectively). Box width is proportional to the square root of n for each group. Absence values indicate the parameter was non-detectable in any of the samples.

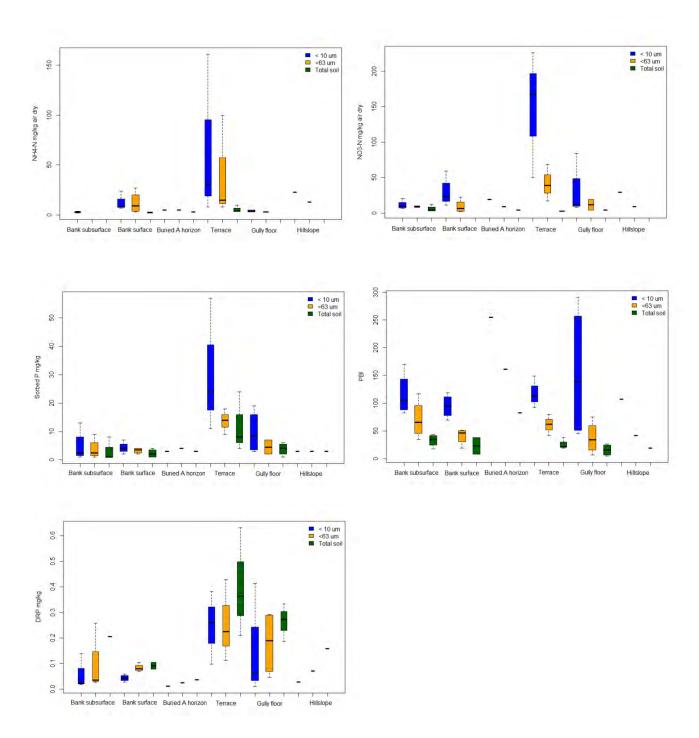
**Figure C16:** Ammonium (NH4-N), nitrate (NO3-N), sorbed P, phosphorus buffer index (PBI) and dissolved reactive P (DRP) by gully geomorphology component for the total (green), <63 um (yellow) and <10 um (blue) particle size fractions. Boxes are intersected by median values and enclose data between the first and third quartiles, with lines extending to maximum and minimum values excluding outliers (values above and below 1.5 times the inner quartile range from the first and third quartiles, respectively). Box width is proportional to the square root of n for each group. Absence values indicate the parameter was non-detectable in any of the samples.

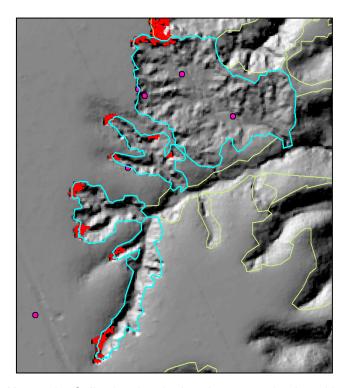
**Figure C19:** Granite Normanby Gully showing the headscarp erosion in red between 2011 & 2015. Also shown (purple dots) are the sample locations for the gully. Note that the erosion detected by the aerial LiDAR in this gully is an absolute minimum amount of erosion due to the conservative limit of detection applied (0.5m change).

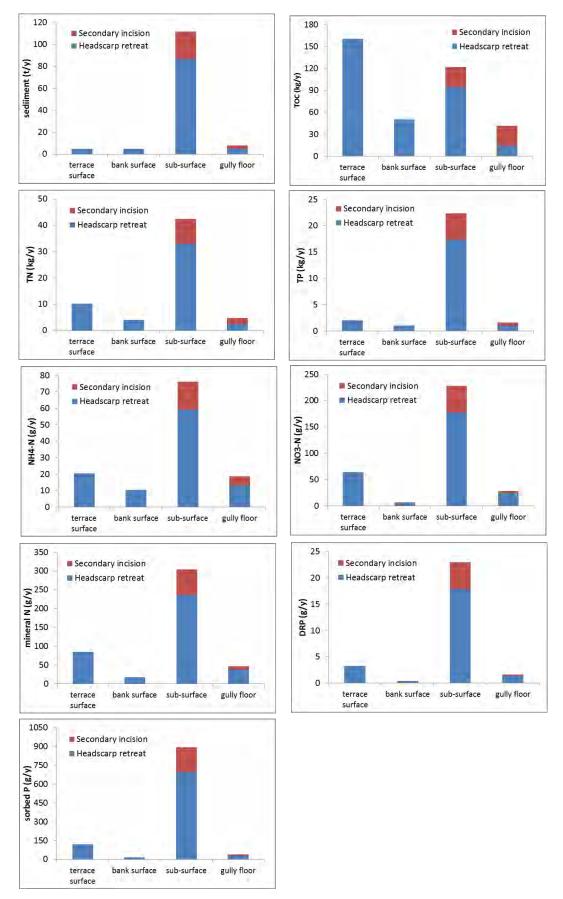
**Figure C20:** Estimated annual mass contributions of sediment, organics and nutrient export from different geomorphic units in the Granite Normanby alluvial gully.

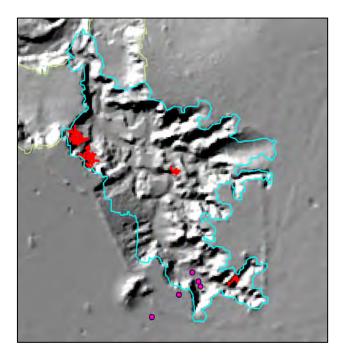
**Figure C22:** Crocodile Station gully showing the headscarp erosion in red between 2011 & 2015. Also shown (purple dots) are the sample locations. Note that the erosion detected by the aerial LiDAR in this gully is an absolute minimum amount of erosion due to the conservative limit of detection applied (0.5m change).

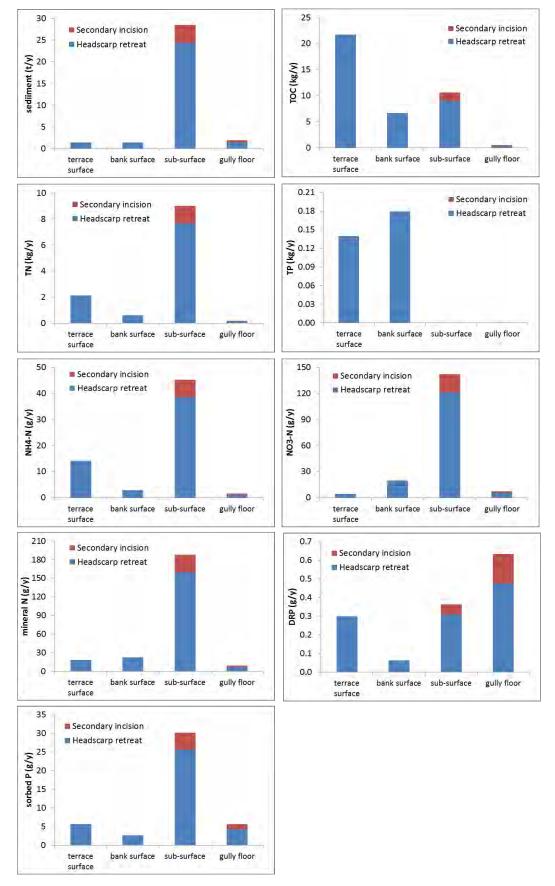
**Figure C23:** Estimated annual mass contributions of sediment, organics and nutrient export from different geomorphic units in the Laura Crocodile Station alluvial gully.

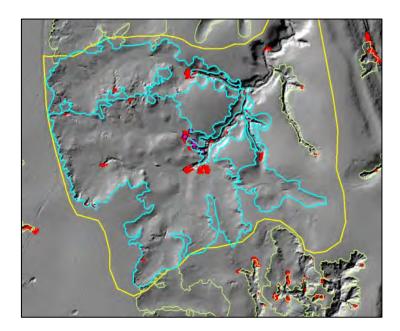
**Figure C25:** Laura Crocodile Gap alluvial gully complex showing the headscarp & secondary incision erosion in red between 2011 & 2015. Also shown (purple dots) are the sample locations. Note that the erosion detected by the aerial LiDAR in this gully is an absolute minimum amount of erosion due to the conservative limit of detection applied (0.5m change).

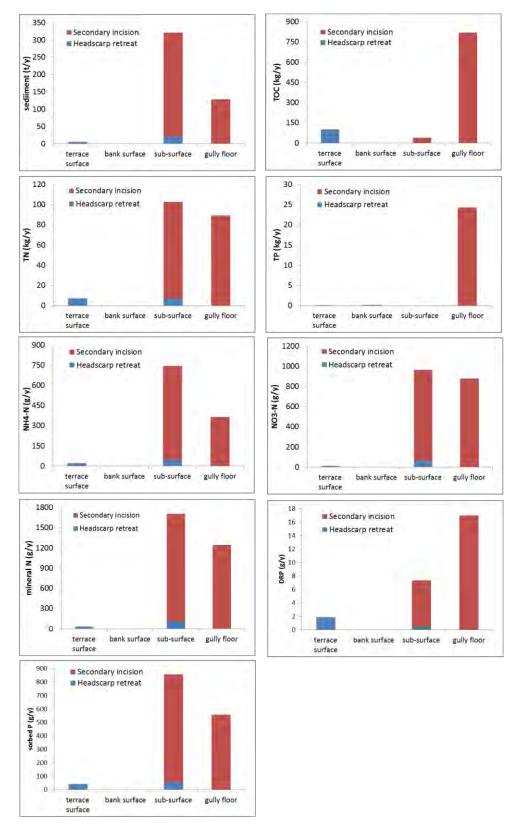
**Figure C26:** Estimated annual mass contributions of sediment, organics and nutrient export from different geomorphic units in the Laura Crocodile Gap alluvial gully

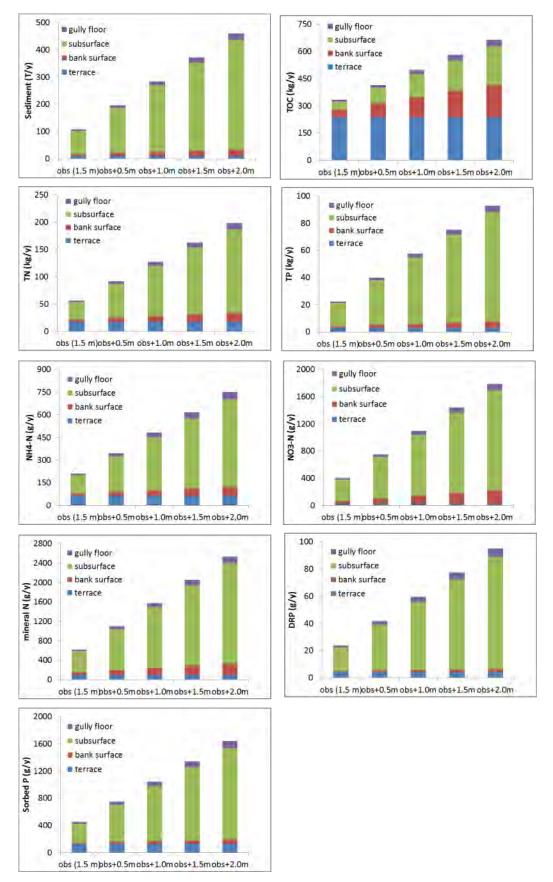
**Figure C29:** Estimated annual mass contributions of sediment, organics and nutrient export from different geomorphic units in a hypothetical developing alluvial gully.
