# **A disturbance index approach for assessing water quality threats in Eastern Cape York**

**Appendix 1: A report to South Cape York Catchments  
and Cape York NRM for the Cape York  
Water Quality Improvement Plan (Report  
No ARI16AB002)**

**Australian Rivers  
Institute Griffith  
University**

Feb 2016

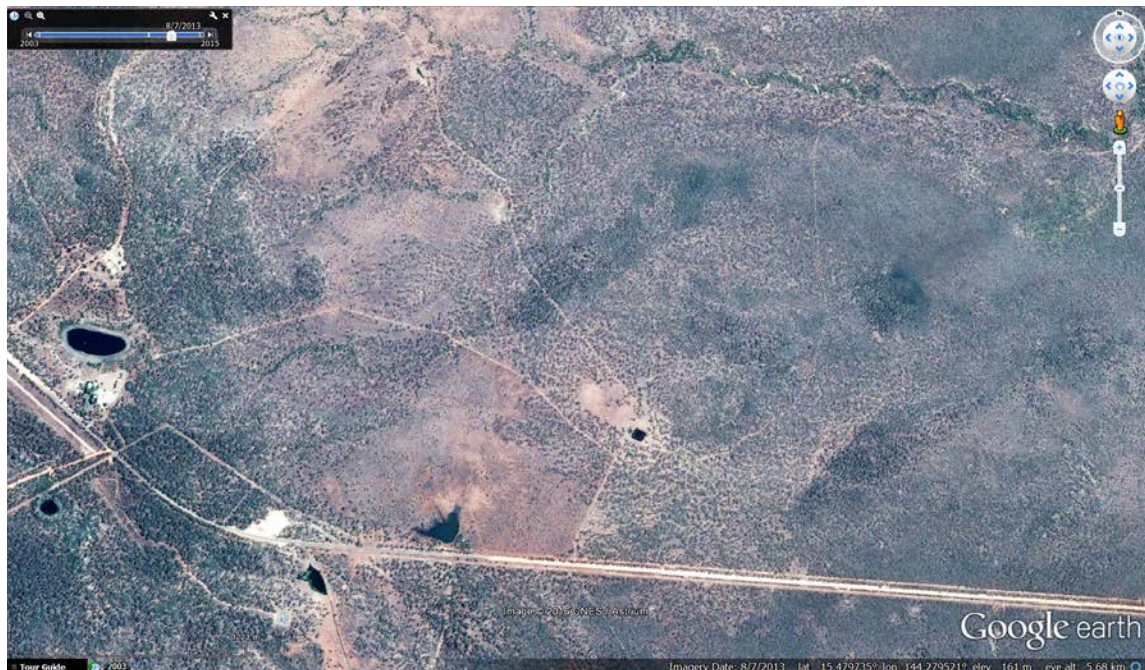
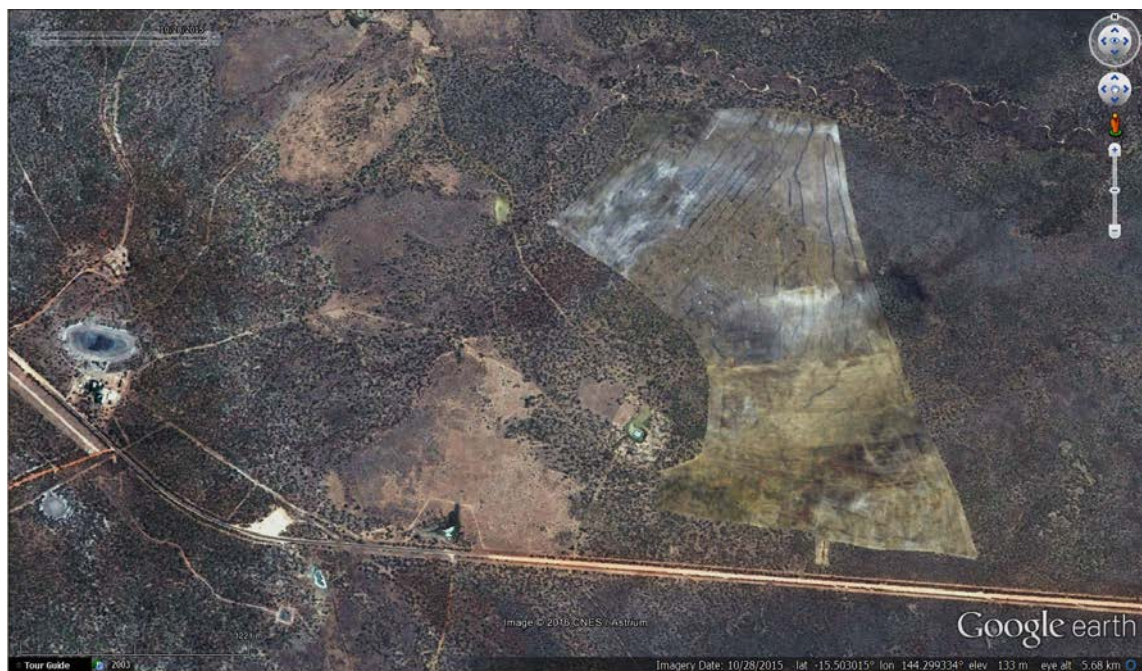
Olive Vale Station Development for Intensive agriculture 2013 image (top) and 2015 (bottom)

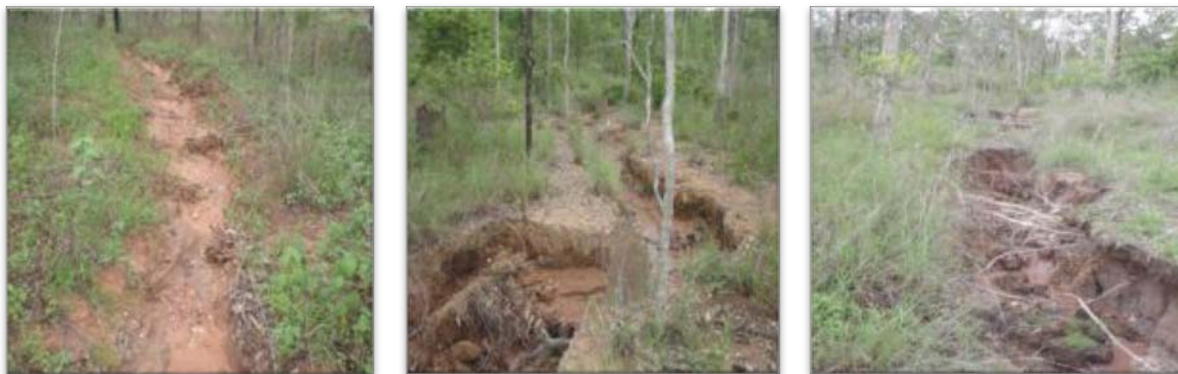
Figure 2 Examples of gullies emanating from road drains within the study area. 42% of road drains in the study area were found to have gullies like this associated within them

The delivery of road surface runoff and suspended sediment was also observed to occur via gully pathways originating from road drainage outlets. It was estimated that a mean volume per drain of 132 m<sup>3</sup> of soil has been

displaced due to the formation of gullies at the outlet of 42% of the all V-Drains analysed in the study (Figure 2). This represents an additional contribution to sediment yield over and above the sediment sourced from the road prism (Table 2). Average V-Drain spacing for the study area is 144m (on both sides of the roads), hence there is potentially around 1800 m<sup>3</sup> of road induced gully erosion per km of main unsealed road (MUSR) that could be contributing to elevated sediment loads within the stream network. It is not known however, over what time span these V drain induced gullies have formed. The presence of exposed roots and active headcuts suggest that these gullies are fresh and active - and it would be safe to assume that at the most we are likely to be talking a decade as the upper limit.

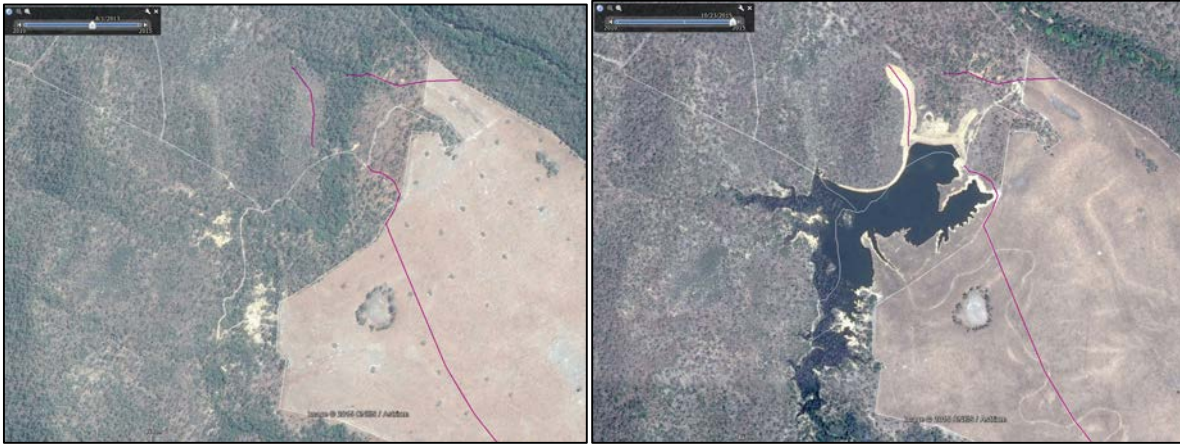
Figure 15 Default imagery shows a paddock with a variety of minor farm tracks in imagery dated 8/1/2013 (Cook paddock Springvale Station on the East Normanby River). Compared with more recent imagery from 10/23/2015 which shows a large farm dam has been built between the two time steps.

Given the rapid pace of development beginning to occur in some parts of the Cape, care needed to be taken to ensure that the most recent image layer was being used within Google Earth when the mapping was undertaken. In some instances the default imagery wasn't necessary the most up-to-date, but more recent imagery was available within the historical image tool. This can provide very useful information as to recent development activities in parts of the landscape. Examples of recent developments are shown in Figure 15 and Figure 16. As a trap for the unwary, Google Earth Pro – always shows the most recent imagery on the default layer whereas standard Google Earth does not necessarily.

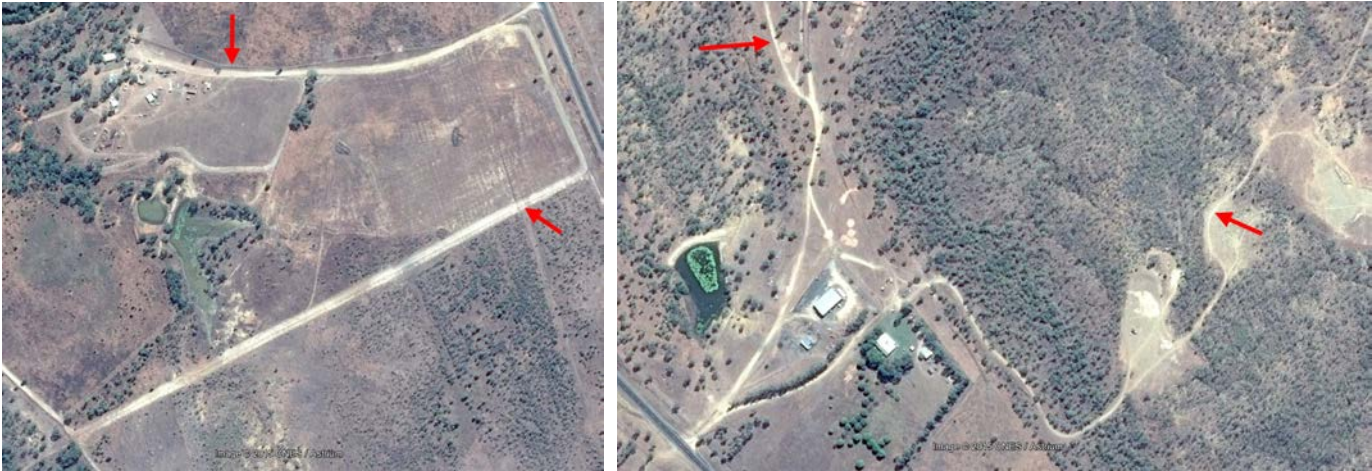
| Classification | Description | Criteria | Width in m |
|---|---|---|---|
| <b>1</b> | Farm tracks major | Unsealed, evidence of well used surface often joining roads to buildings, or main access to strategic farm assets. | 3-8m |

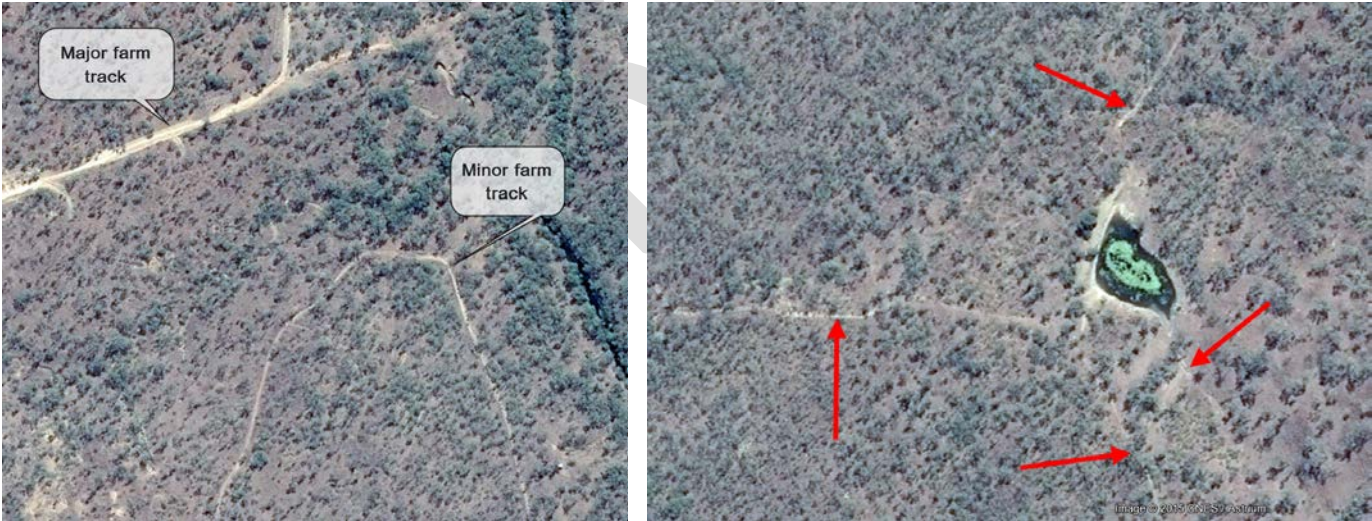
| Classification | Description | Criteria | Width in m |
|---|---|---|---|
| <b>2</b> | Farm tracks minor | Surface may alternate from solid graded to 2 wheel tracks - vegetation may be present up center of track. Provides access to water points, distant parts of country. Width variable as multiple tracks may skirt bogs, gullies, but mainly one and a bit vehicle width wide. | 2-3m |

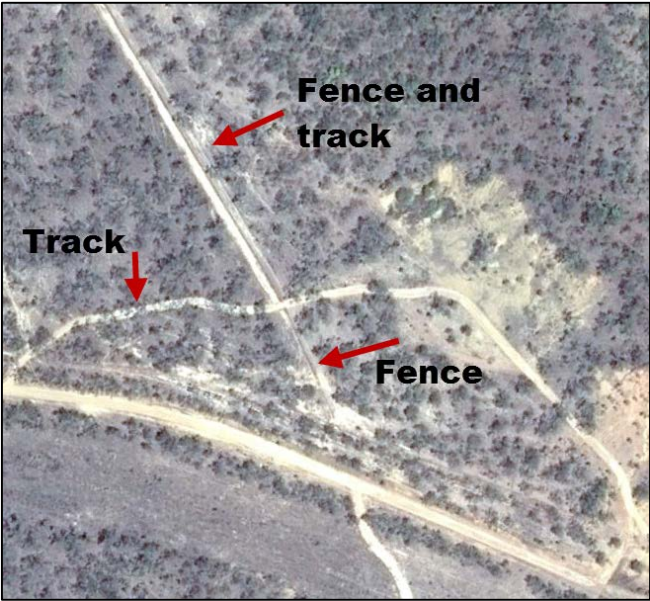
| 5 | Fence lines with roads beside | Obvious bulldozed clearance that includes a road alongside.<br>Has characteristic linear features. | 10 to 14m |

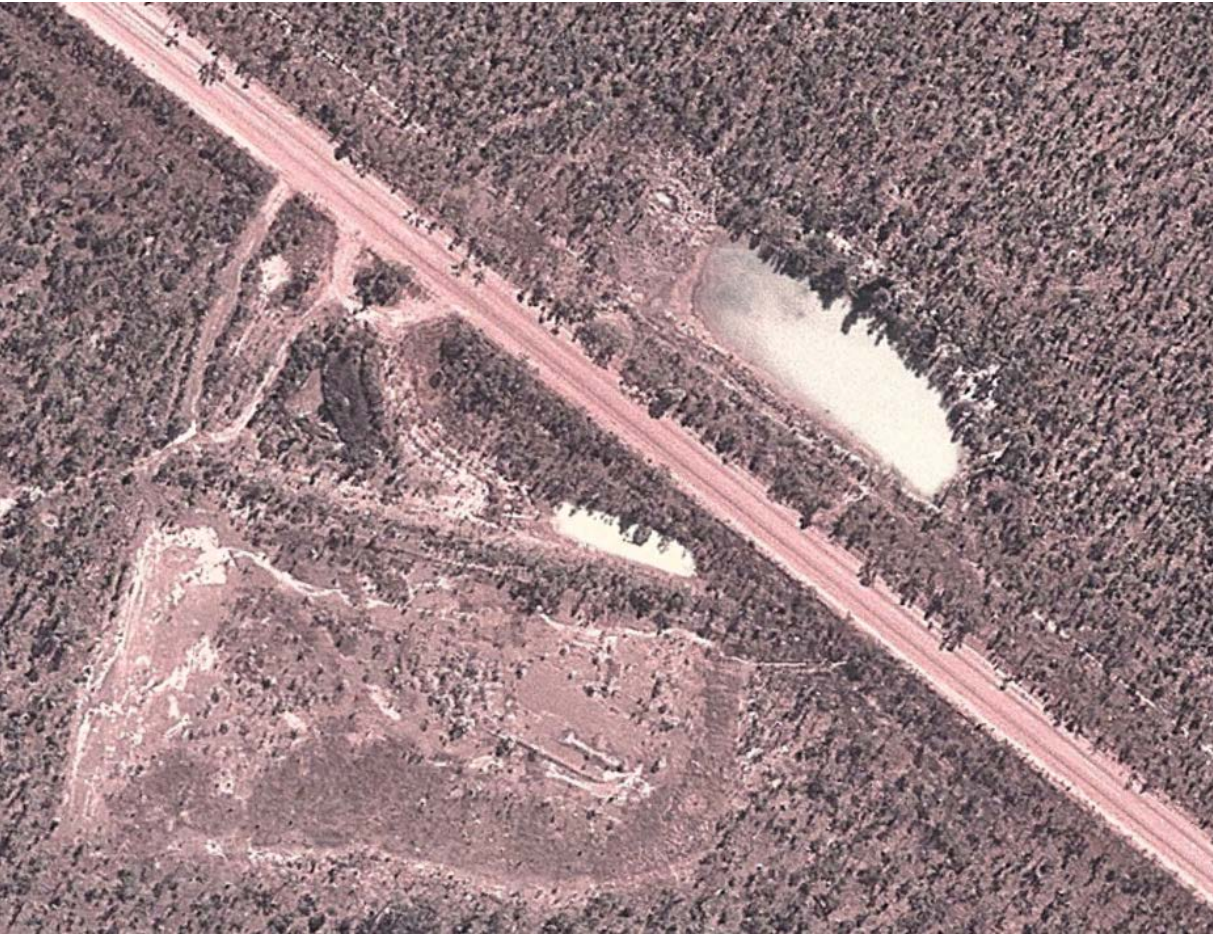
| 6 | Main dirt roads | Unsealed, named developmental roads, dual carriageway, bridges | >10m wide |
| <p>Peninsula Developmental Road beyond the tarseal</p> | | | |

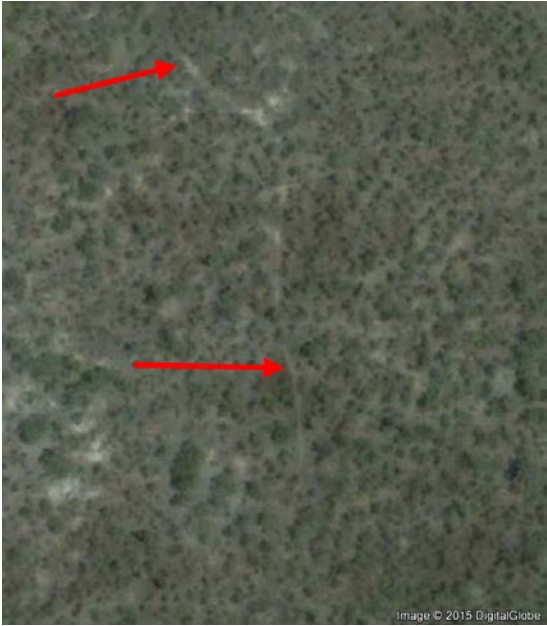
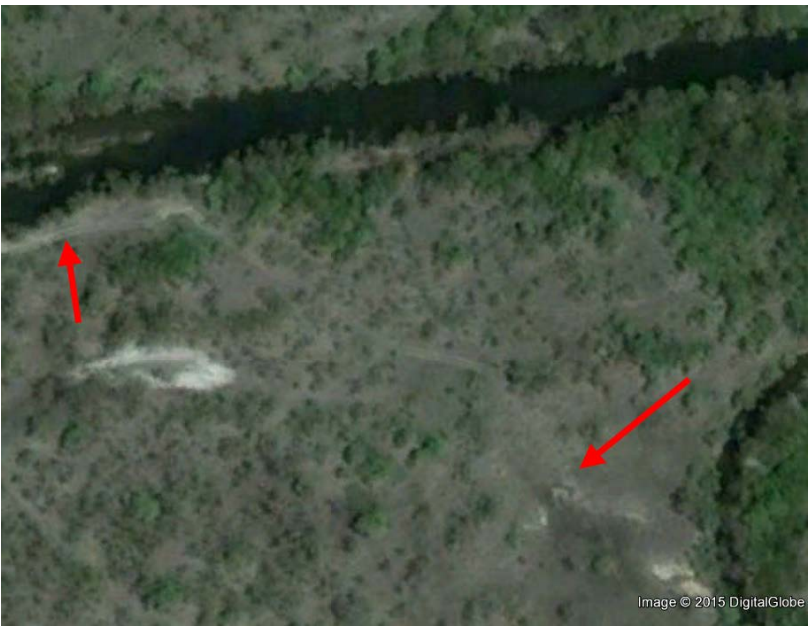
| 7 | 2 wheel tracks | Track seen as 2 wheel lines, indicating occasional use. Often very remote. | Approx. 2m |

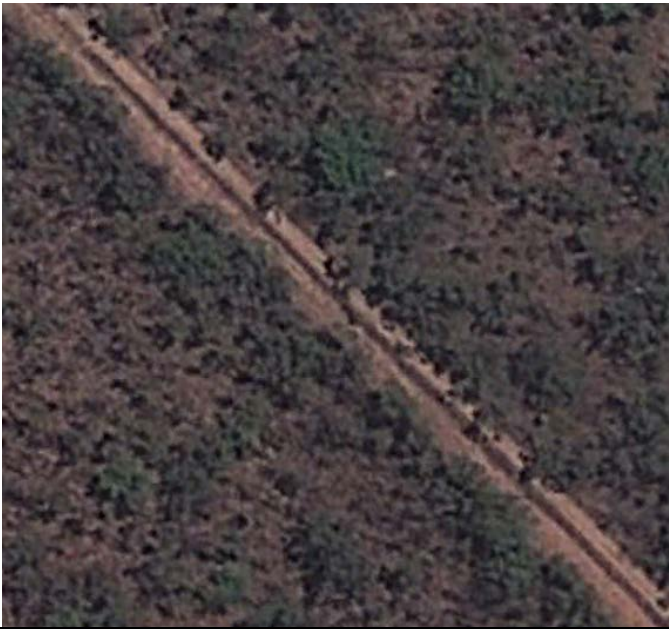
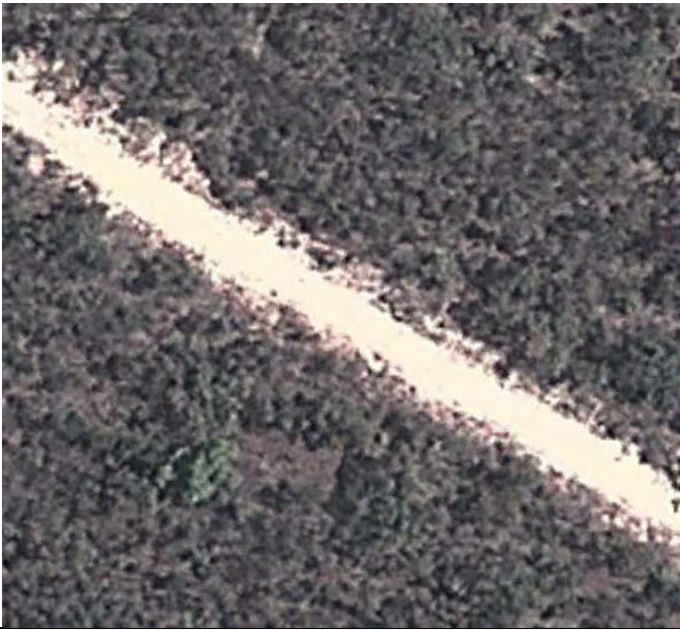
| 8 | Minor dirt roads | Unsealed, less than full dual carriageway, solid appearance, well-travelled, includes driveways to farms | 5-10m |

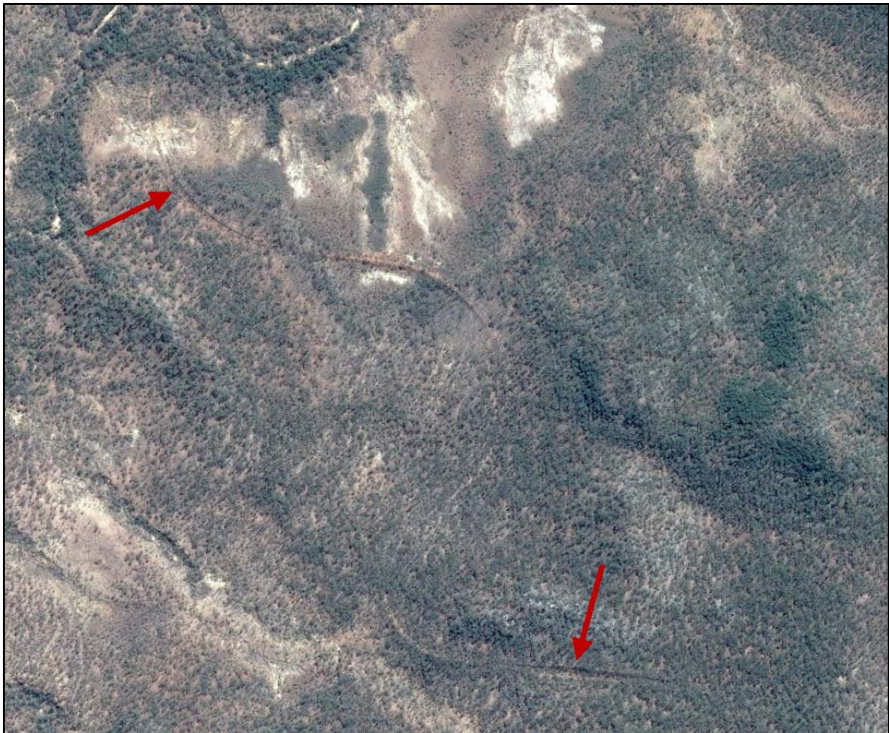
| 9 | Railway Line | Abandoned Cooktown-Laura railway embankment, overgrown. Sinuous path. | 20 to 30m |

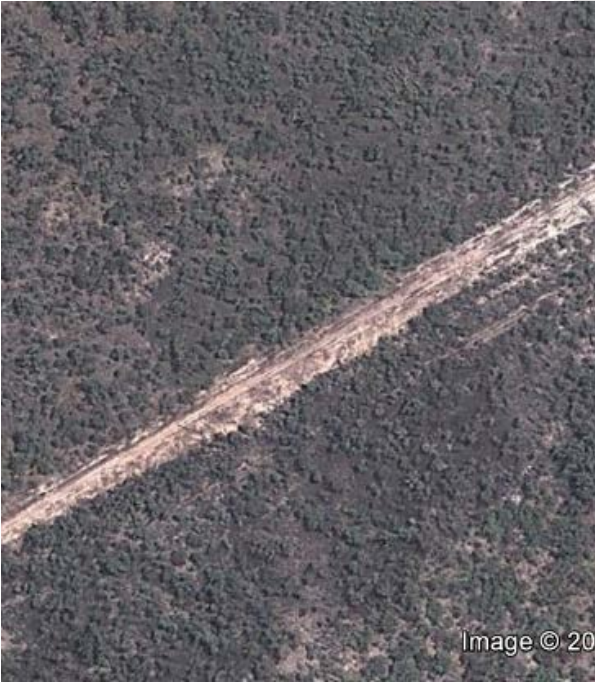
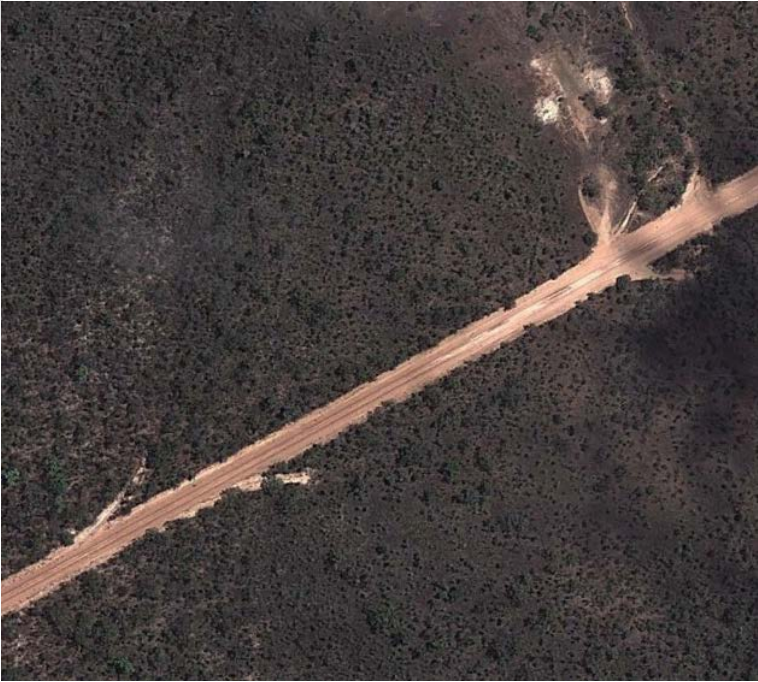
| 10 | Secondary dirt roads | Unsealed, cutouts to divert water, single lane or dual carriageway, bridges | 10-20m |
| <div> <div>WELCOME ROAD</div> </div> <div> <div>BATTLE CAMP ROAD</div> </div> | | | |

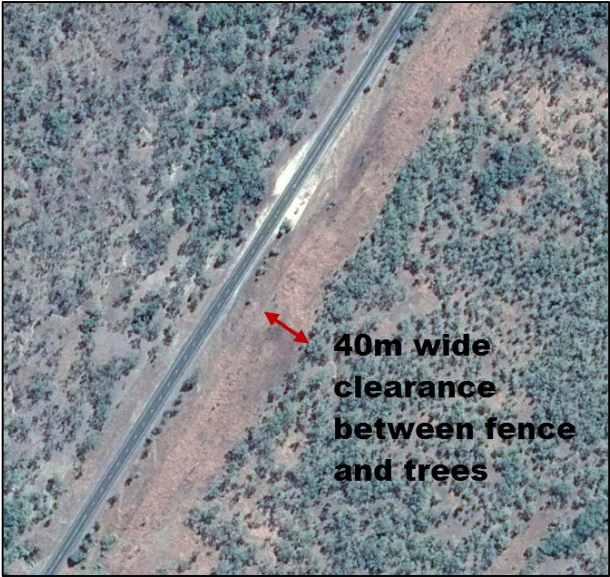
| 11 | Track | Wide clearance of vege without evidence of active road.<br>Possible powerline clearance? Old road alignment. Width variable. | >15m |
| <div><div><p>Cleared track</p><p>Secondary dirt road</p><p>Minor road</p><p>Main highway</p></div><div><p>40m wide clearance between fence and trees</p></div></div> | | | |

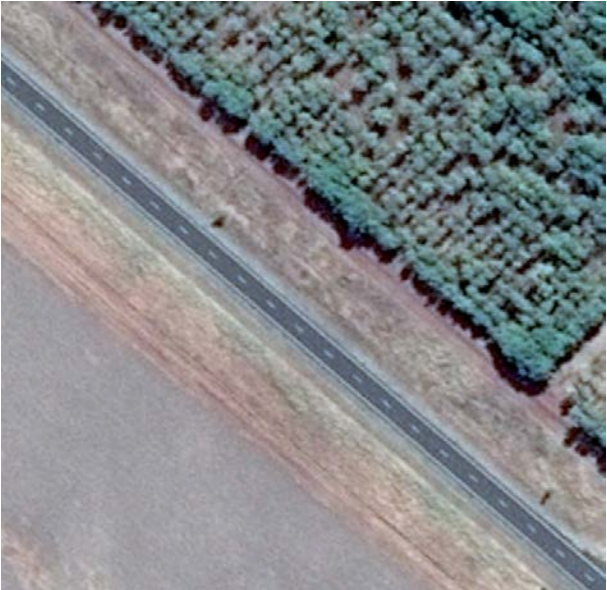
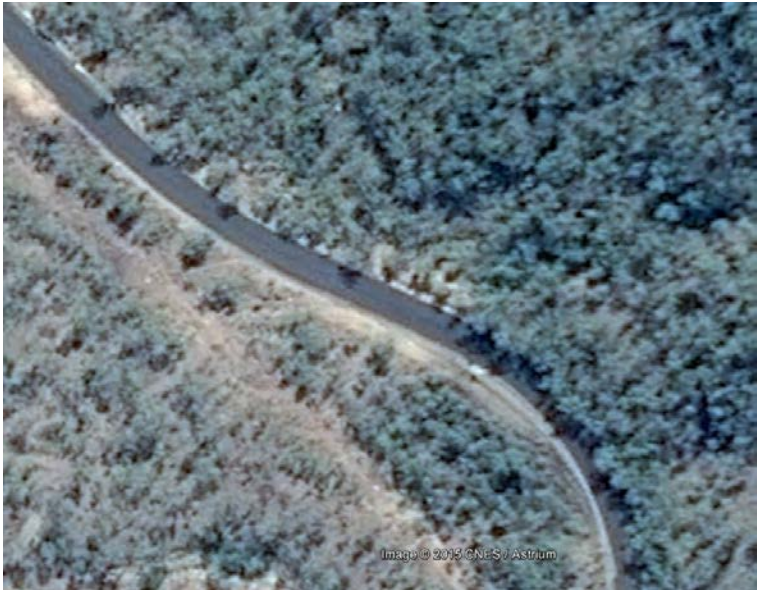
| 12 | Highways | Tarsealed, white line, dual carriageway, bridges, formed shoulder | 20-25m |
| <div>Peninsula Developmental road near Lakeland</div> <div><div></div><div><p>Image © 2013 CNES / Astrum</p></div></div> | | | |

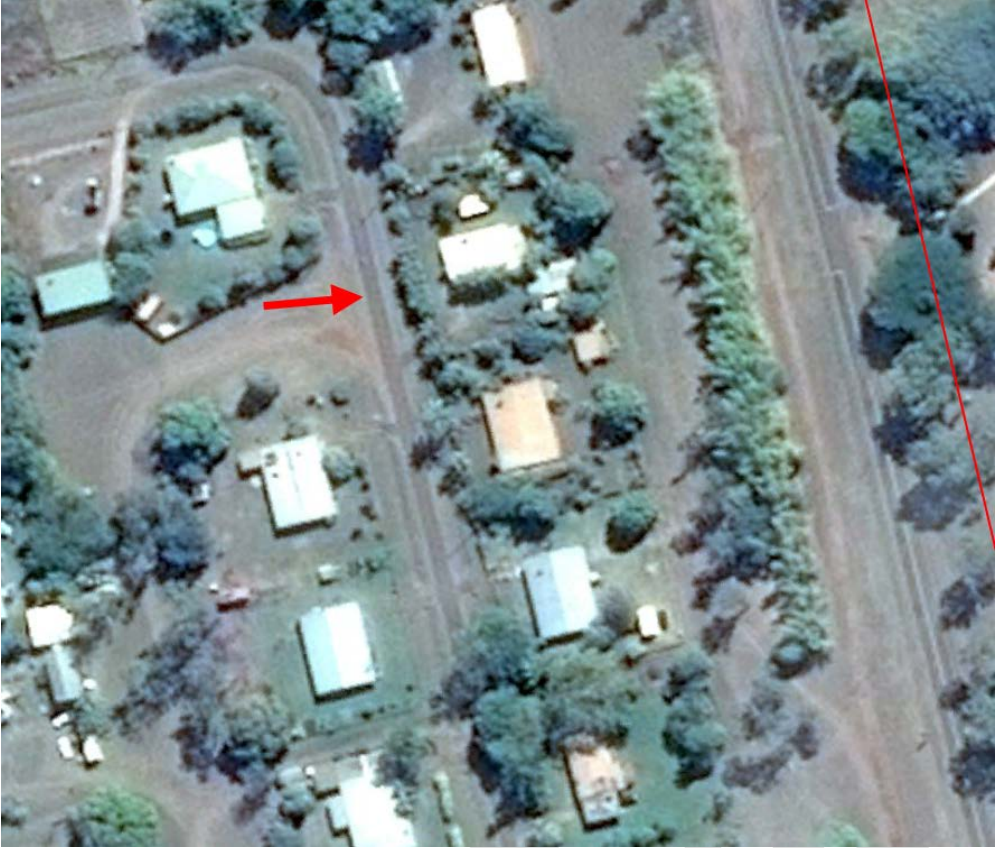
| 13 | Tar sealed roads | Tarsealed, white line optional, in towns or rural zone. | 8-10m |
| Residential streets in Lakeland<br> | | | |

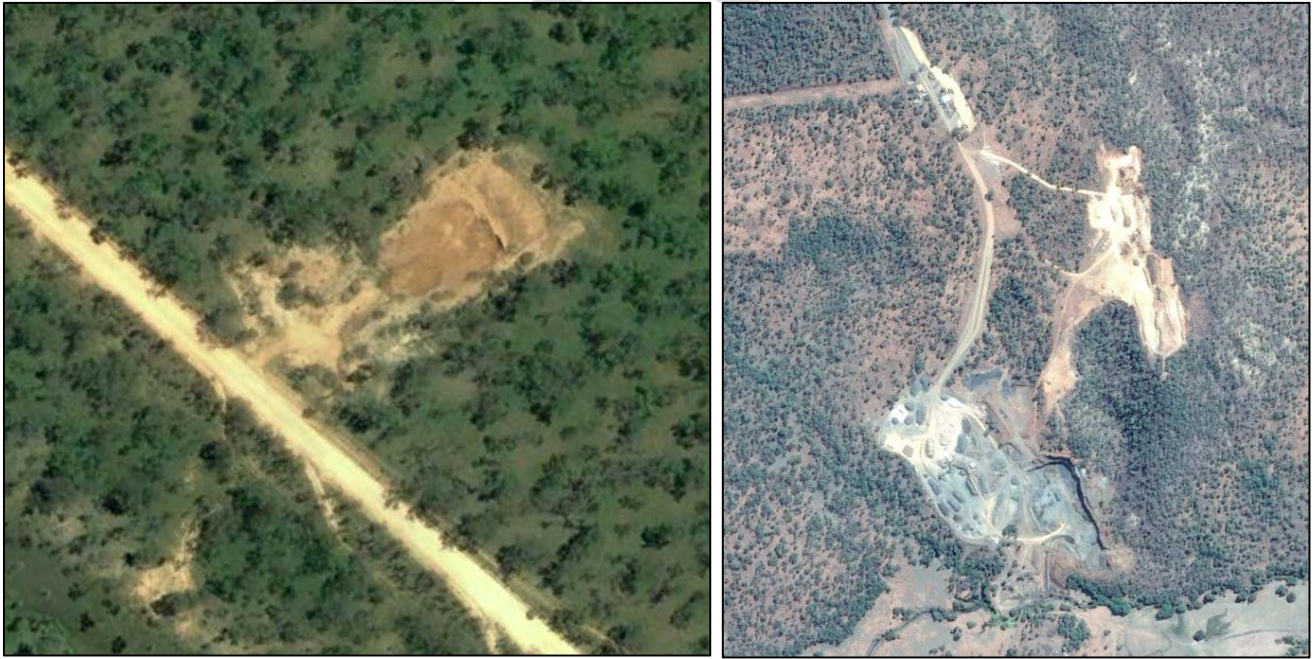
| 14 | Quarry | Obvious working pad for extraction or storage of material. | Width variable, 30-200m |

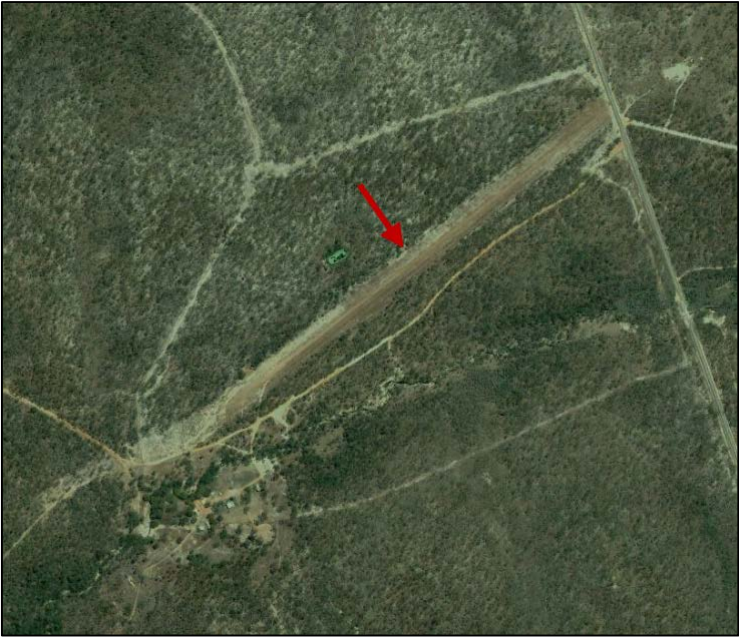
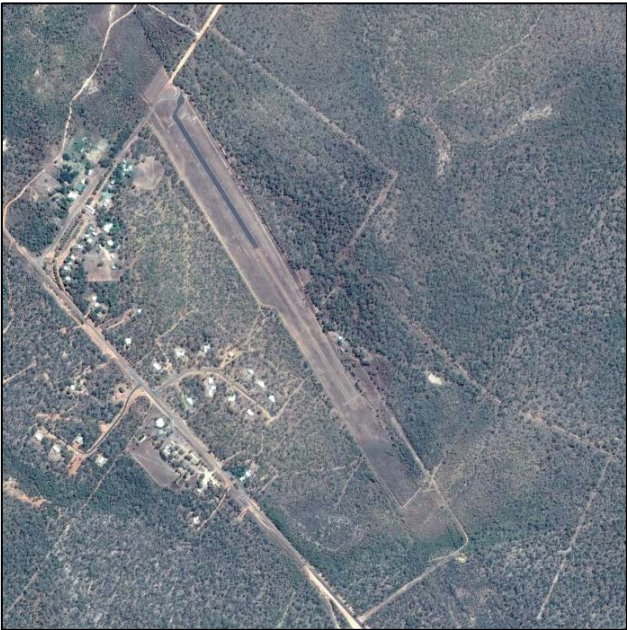
| 15 | Airstrip | Cleared land for landing planes on - long and wide | Width variable.<br>30-120m |

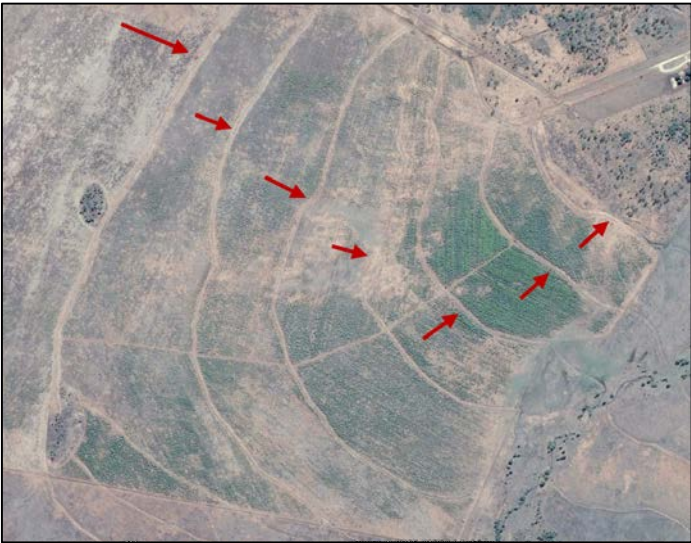
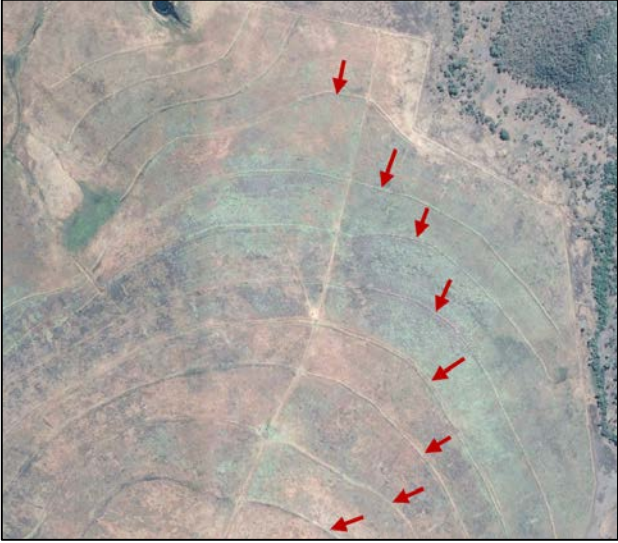
| 16 | Contours | Soil conservation berms across fall line of paddocks | |

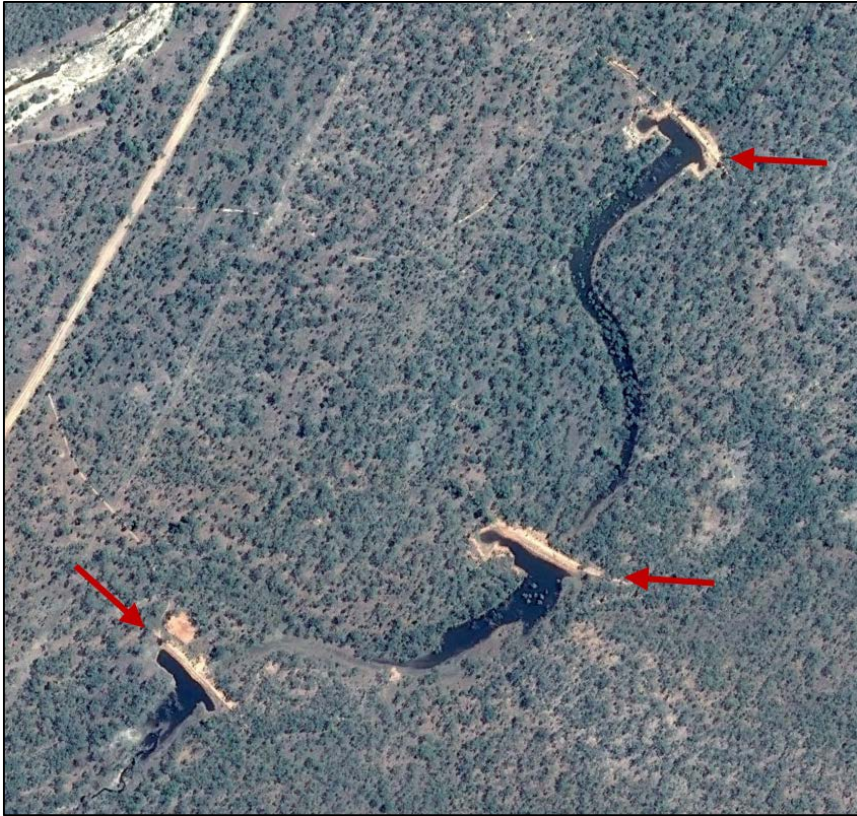
| 17 | Dam across water course | A dam across a watercourse | 30-40m |
